Wash Creek Watershed STORMWATER MASTER PLAN

May 2019

WR Job Number: 2180508

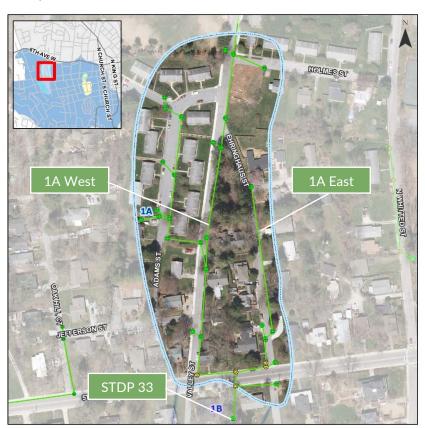
Project Area 1A

This system outlets to STDP 33. There are two main lines of storm drainage that contribute to this outfall:

1A West and 1A East. The drainage area to 1A West was determined to be 14 acres. The drainage area to 1A East was determined to be 7 acres. Both systems are piped systems without open channels. Each of these systems is located within the right-of-way.

The conveyance analysis results show that the storm drainage outfall where these two systems meet is adequately sized for the modeled flows however the condition may require replacement. The upstream systems are not sized to convey the design storm and should be upsized.

Recommendation: Both pipe systems 1A East and 1A West should be upgraded in order to convey the design storm. Site evaluation of the culvert at STDP 33 is recommended to determine if the pipe should be replaced.

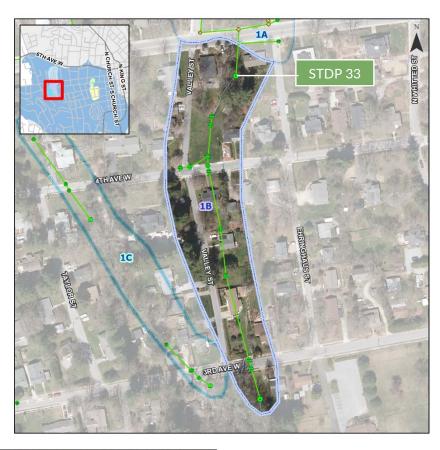
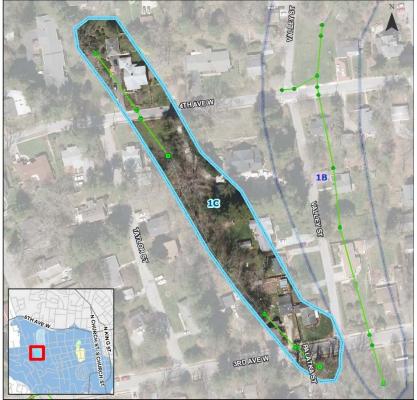
Project Area 1B

This system is just downstream of Project Area 1A. The drainage area totals 29 acres. The system is comprised of an open channel from discharge point at STDP 33 which then transitions to a subsurface network of 24" VCP and concrete box culverts. The system traverses through private property.

The system is not adequately sized to handle the design storm as modeled.

It is recommended that the materials and pipe size be upgraded as well as rerouting the system to stay within the right-of-way.

This recommendation requires the addition of a minimum of 2 junction boxes as well as an

additional 100 linear feet of storm drainage.

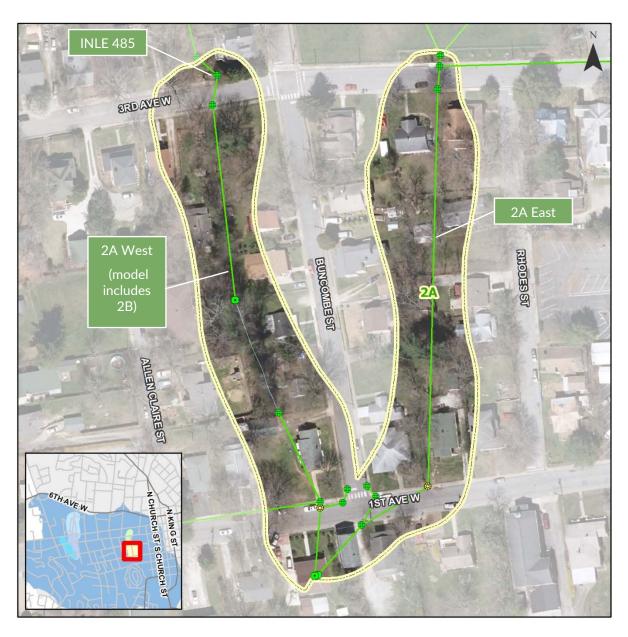
Project Area 2A

Similar to Project 1A, Project 2A is comprised of two main storm drain networks that converge at one outfall point. Each system was analyzed as 2 distinct systems; Project 2A East and Project 2A West. The drainage area to Project 2A East is 32 acres while the drainage area to Project 2A West is 38 acres. Project 2A East is a piped system where as the Project 2A West has portions of open channel. Both systems are located on private property with portions crossing the right-of-way.

Project 2A East is undersized for the majority of network. The pipe size is reduced midway through which restricts flow.

Project 2A West is undersized up until the stream. Then the stream and downstream infrastructure adequately handle the flow in the design storm. The undersized portion has been identified separately as Project 2B below.

Recommendation: Improvements to the 2A should include upgrading the pipe that is currently restricting flow. This 15" pipe goes through an open space area. It is recommended that the pipe size be upgraded throughout this network and that the pipe through the open area be realigned through the nearby parking lot that then ties into the right-of-way. Easements may be required.

It is also recommended that the drainage systems be located into the right-of-way. The west alignment is proposed to move into Buncombe Street. The East alignment is proposed to go into Rhodes Street. This adds approximately 195 LF and 4 structures for the realignment along Rhodes Street and 270 LF and 1 additional structure for the realignment along Buncombe Street

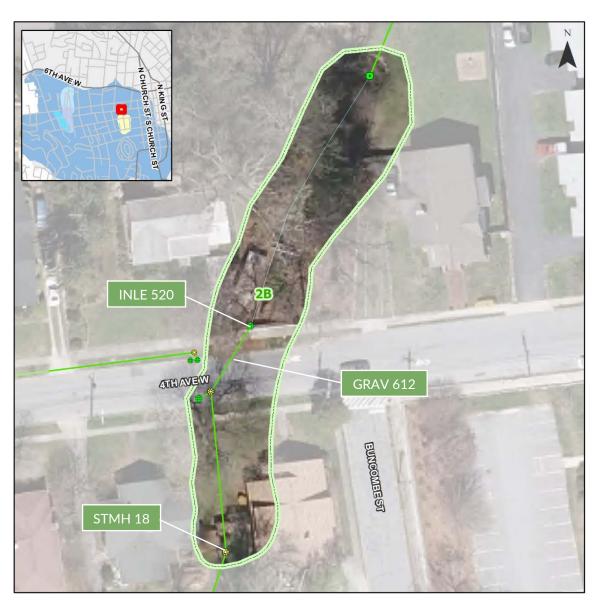
Project Area 2B

Modeled as part of the west side of Project 2A, only a portion of this network was deemed inadequate. The portion of the network from INLE 520 to INLE 485 is considered Project Area 2B.

Recommendation: The culvert crossing the road, GRAV 612 is recommended to be upgraded up through manhole STMH18.
