**BRITTON CREEK
STORMWATER MASTER PLAN**

**CITY OF HENDERSONVILLE
HENDERSON COUNTY, NORTH CAROLINA**

June, 2011

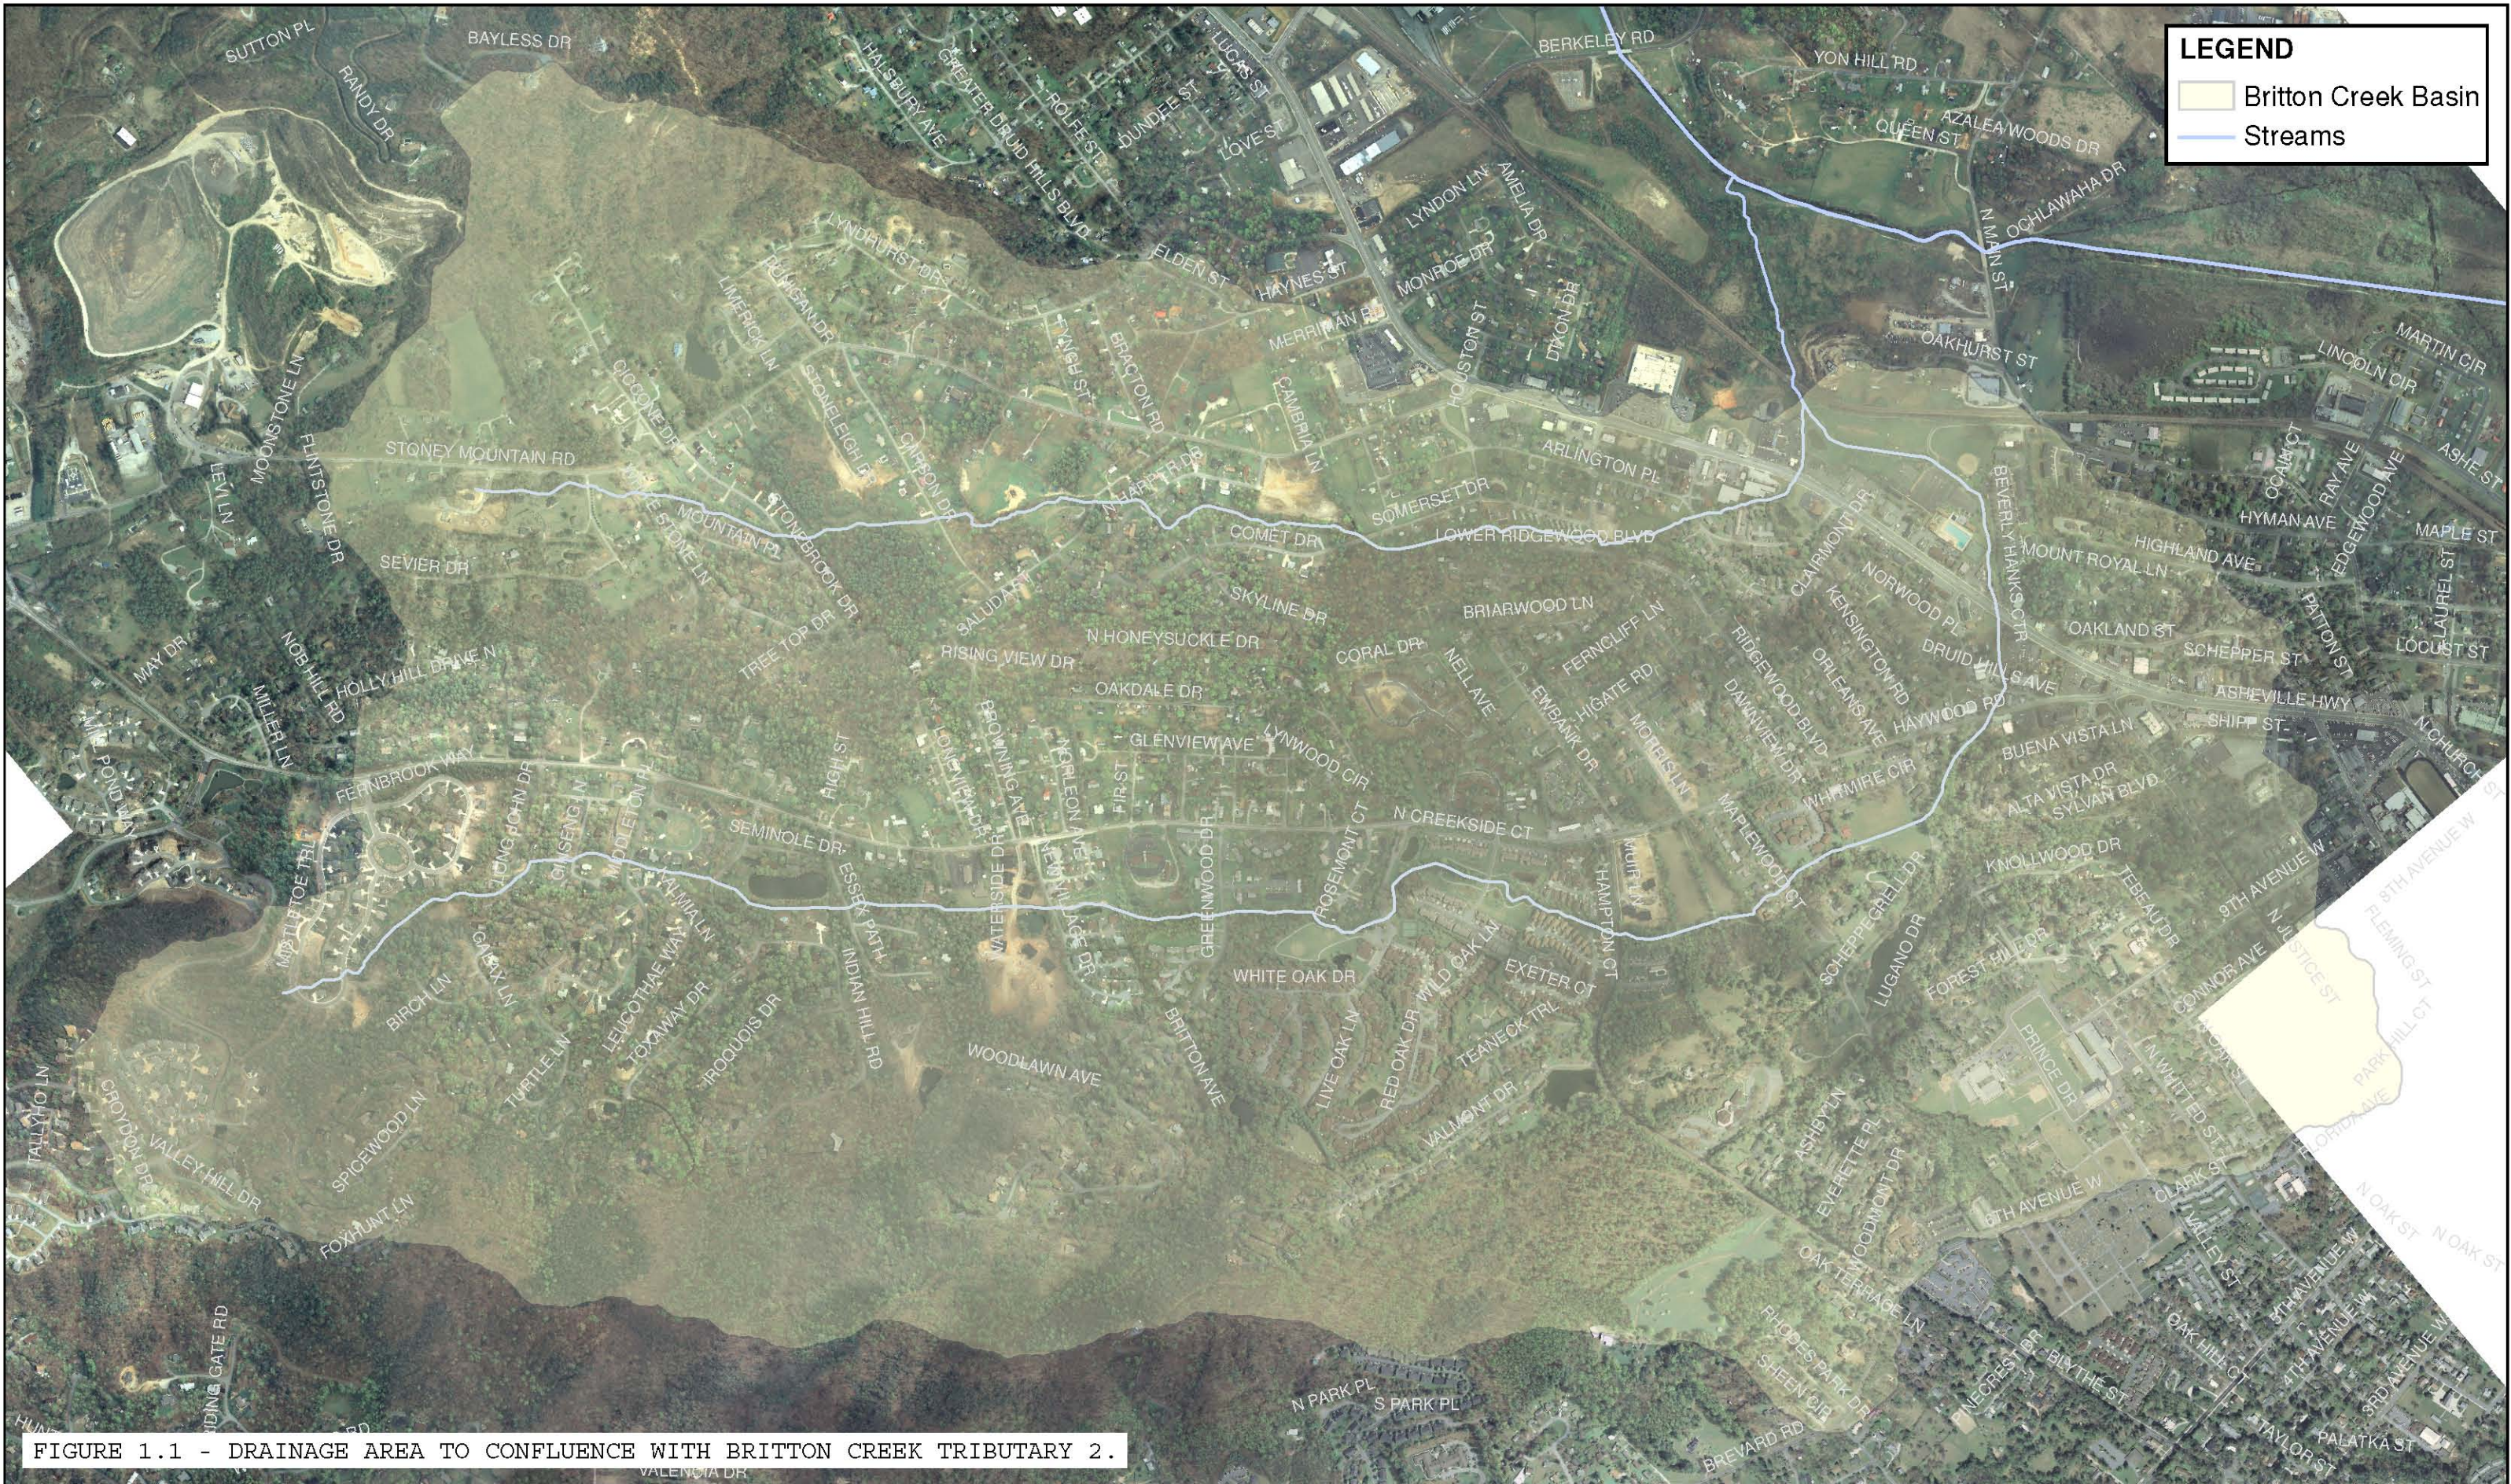
BRITTON CREEK WATERSHED: CITY OF HENDERSONVILLE, NC
 DRAINAGE AREA TO CONFLUENCE WITH BRITTON CREEK TRIBUTARY 2

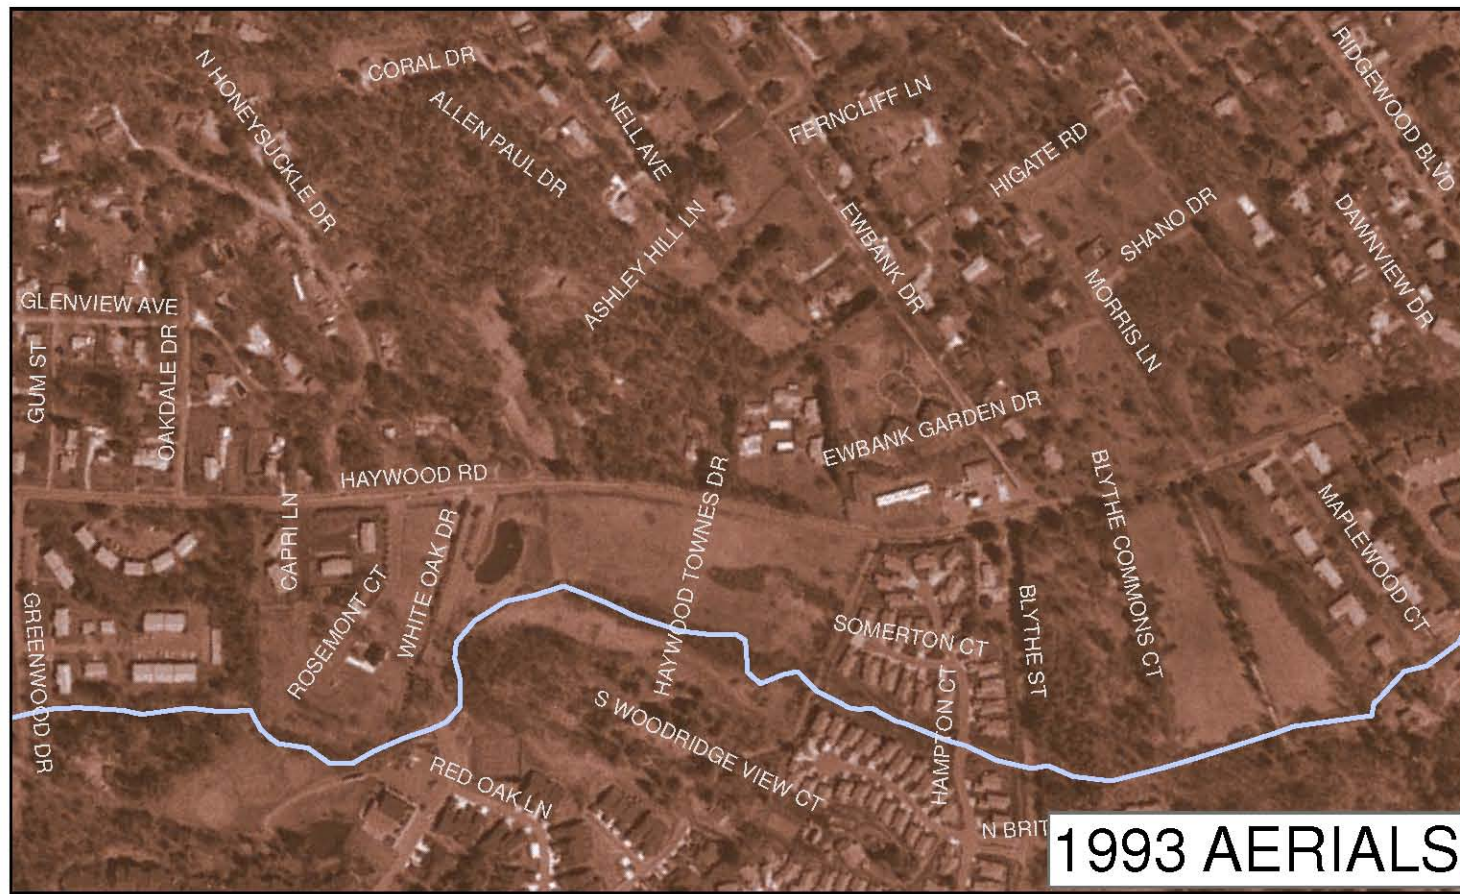
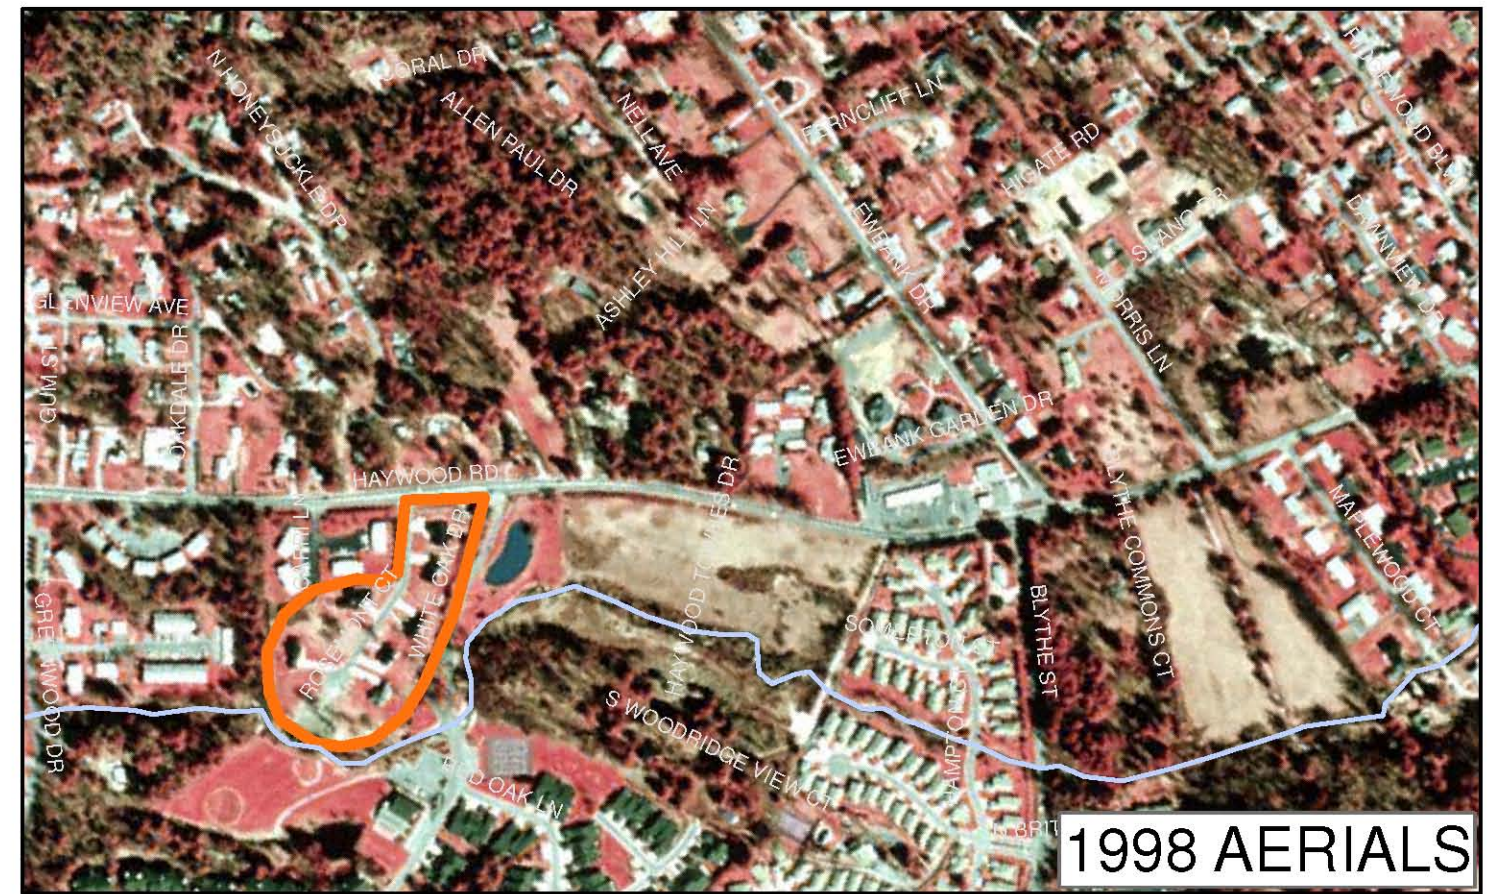
FIGURE 2.2 - EXAMPLE AREA SHOWING DEVELOPMENT OVER THE PERIOD FROM 1993 TO 2007.
 BRITTON CREEK WATERSHED: CITY OF HENDERSONVILLE, NC
 EXAMPLE OF DEVELOPMENT OVER THE PERIOD FROM 1993 TO 2007

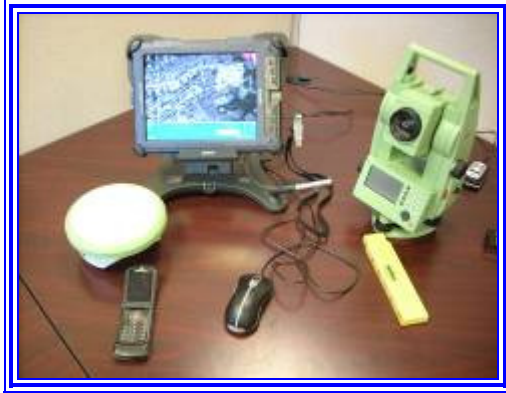
Figure 3.1: Leica Mobile Matrix Equipment

The Leica Mobile Matrix equipment is shown in Figures 3.1 and 3.2.

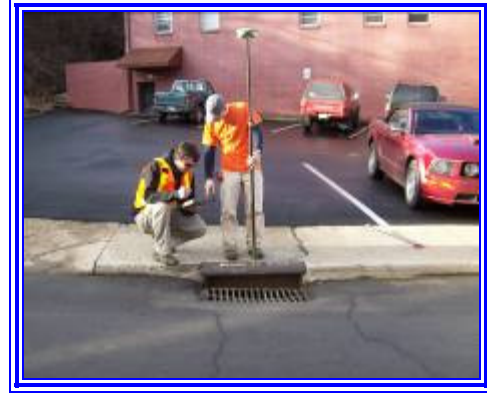
Figure 3.2: Collecting data using Mobile Matrix

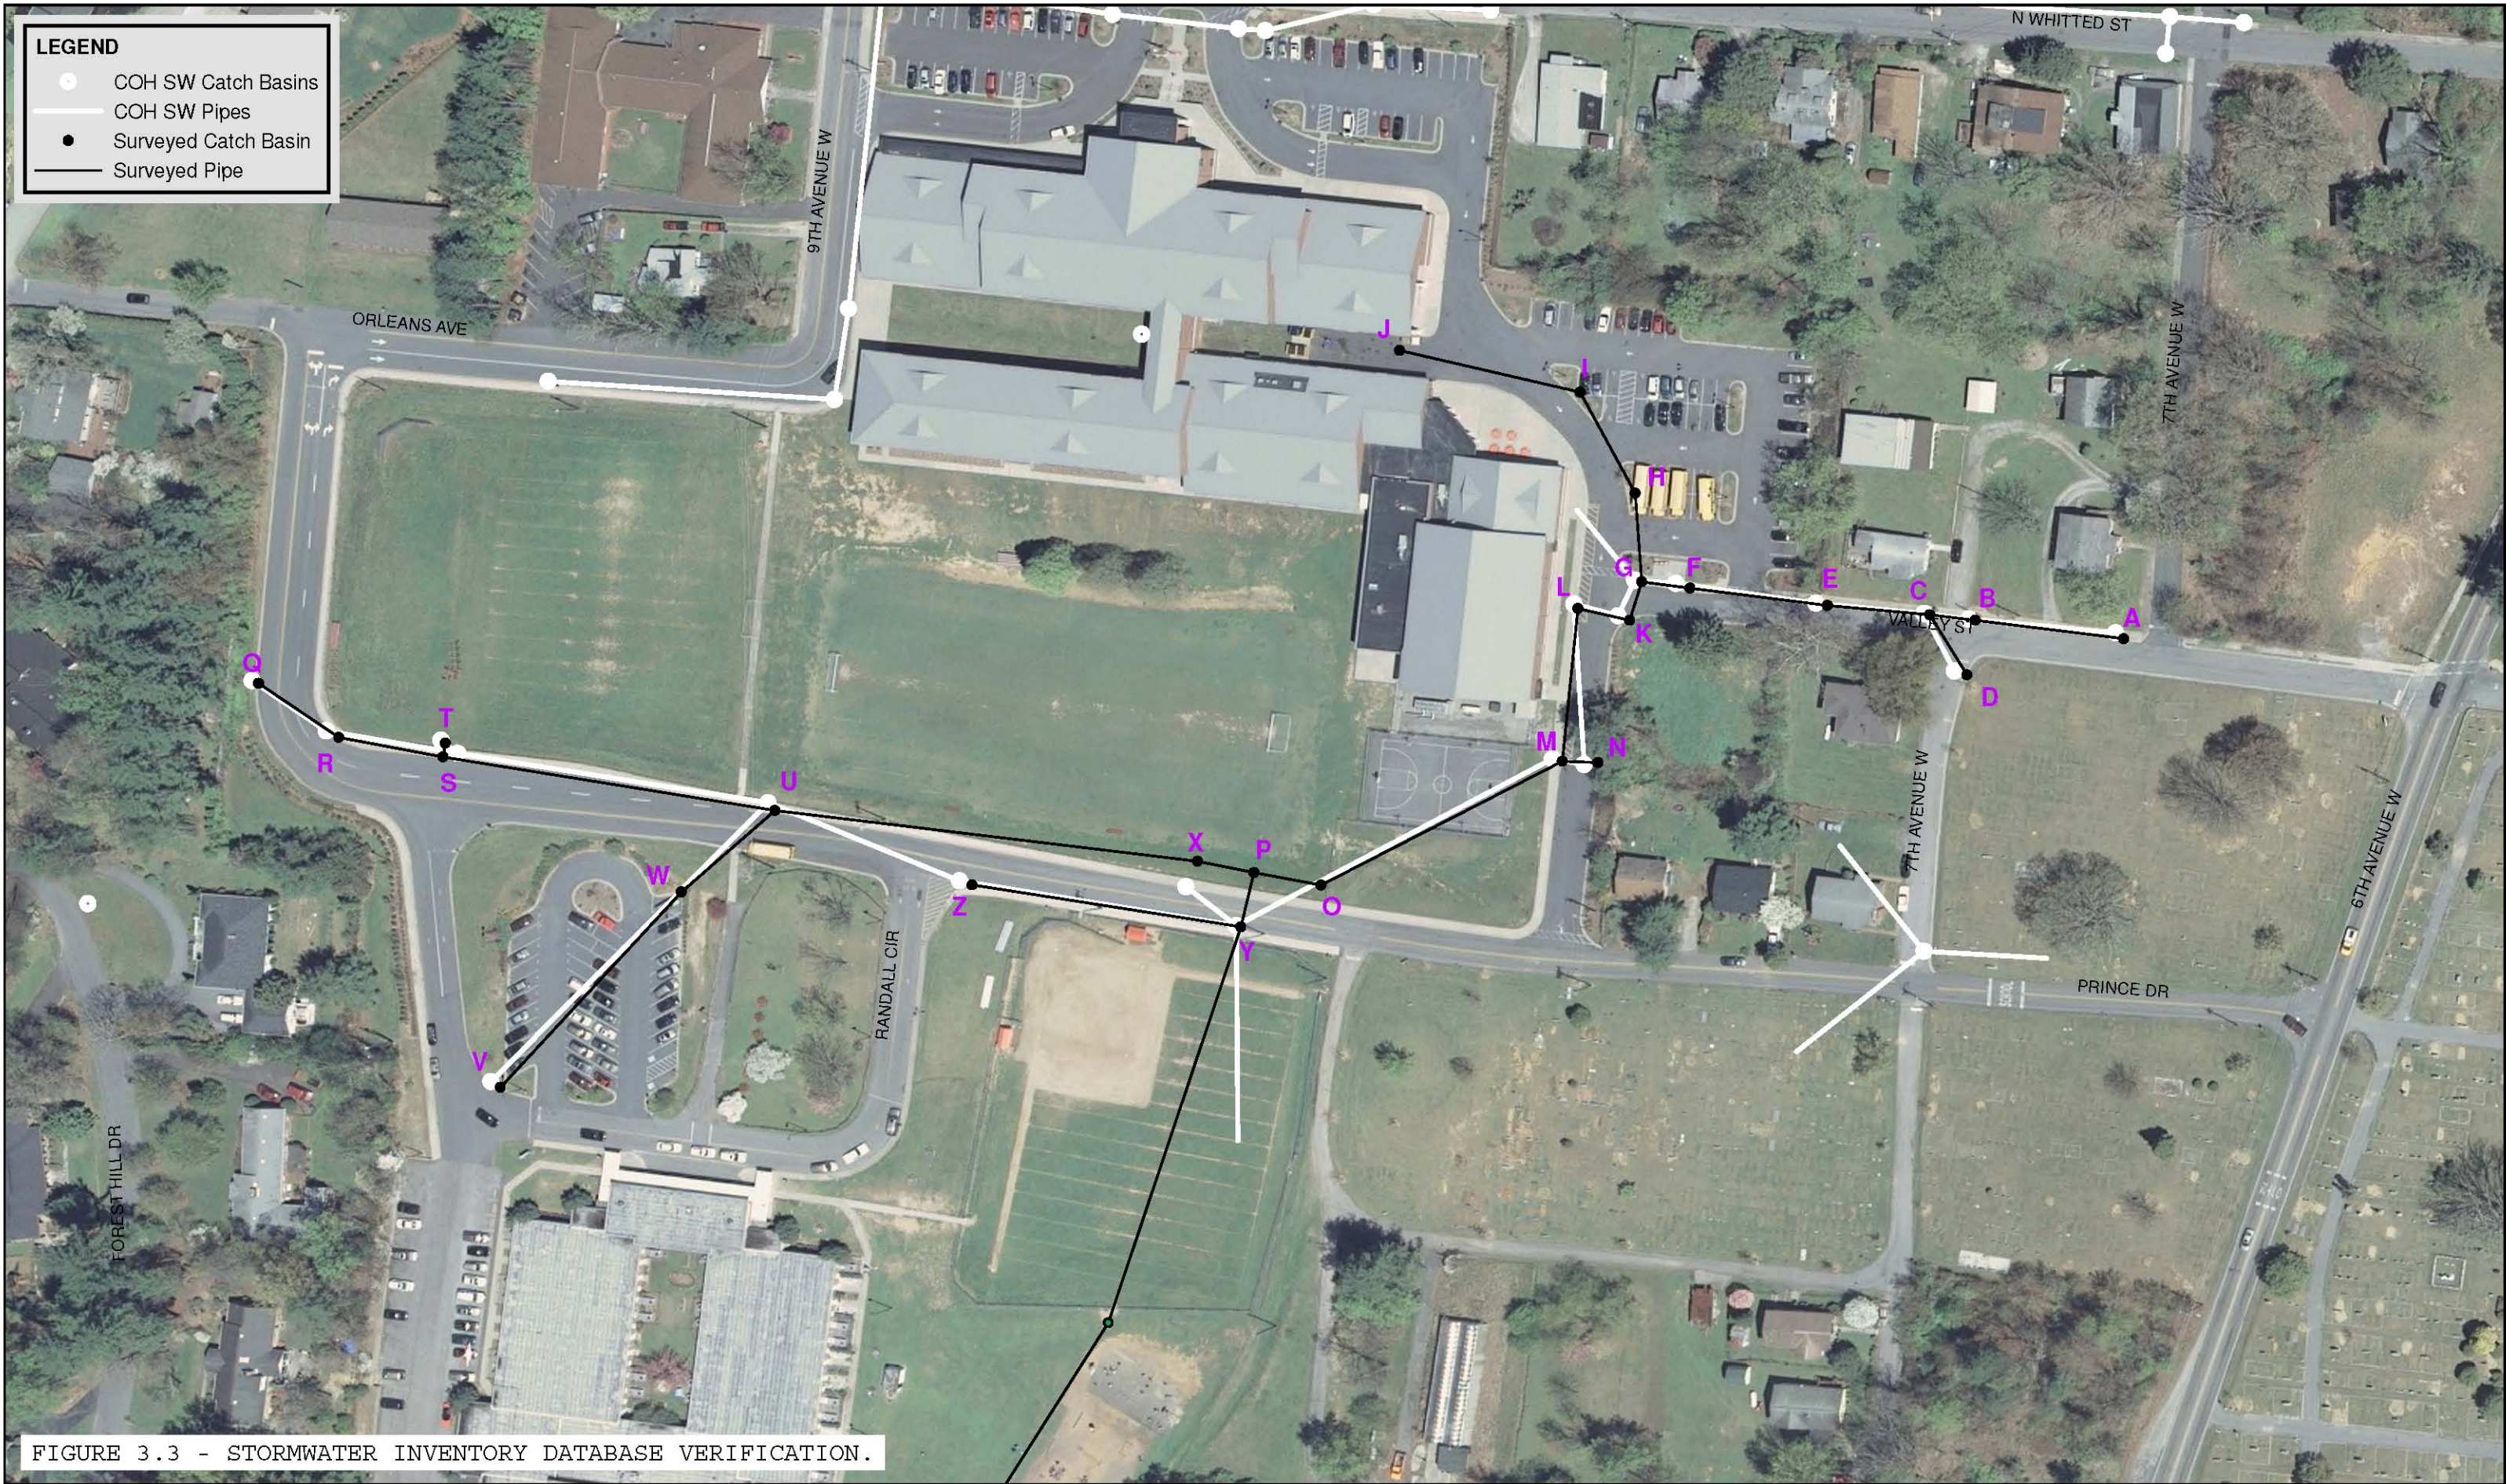
HENDERSONVILLE ELEMENTARY/MIDDLE SCHOOLS: HENDERSONVILLE, NC
 STORMWATER INVENTORY DATABASE VERIFICATION

Twenty-six catch basins and twenty six pipes were collected using the same survey equipment described in Section 3.2. The catch basins are labeled from A-Z on Figure 3.3. The system of catch basins and pipes shown in white was previously collected as part of City's stormwater database. The system shown in black lines and points was collected as part of the current survey. Table 3.2 shows the variation measured in feet between the previous and current survey. Six structures that were collected in the current survey were not part of the previous survey. Those are indicated in the table by a dash mark. The average deviation in position is 7.3 feet for the area surveyed.

It should also be noted that the pipe routing differed in two areas. Just east of the baseball field, the pipe network was surveyed to have a junction within the middle school field rather than across Prince Drive near the sidewalk. Also, next to the wing of the middle school closest to the basketball court there are inconsistencies between the mapped networks. Some of this may be due to improvements that have been made since the previous survey was conducted.

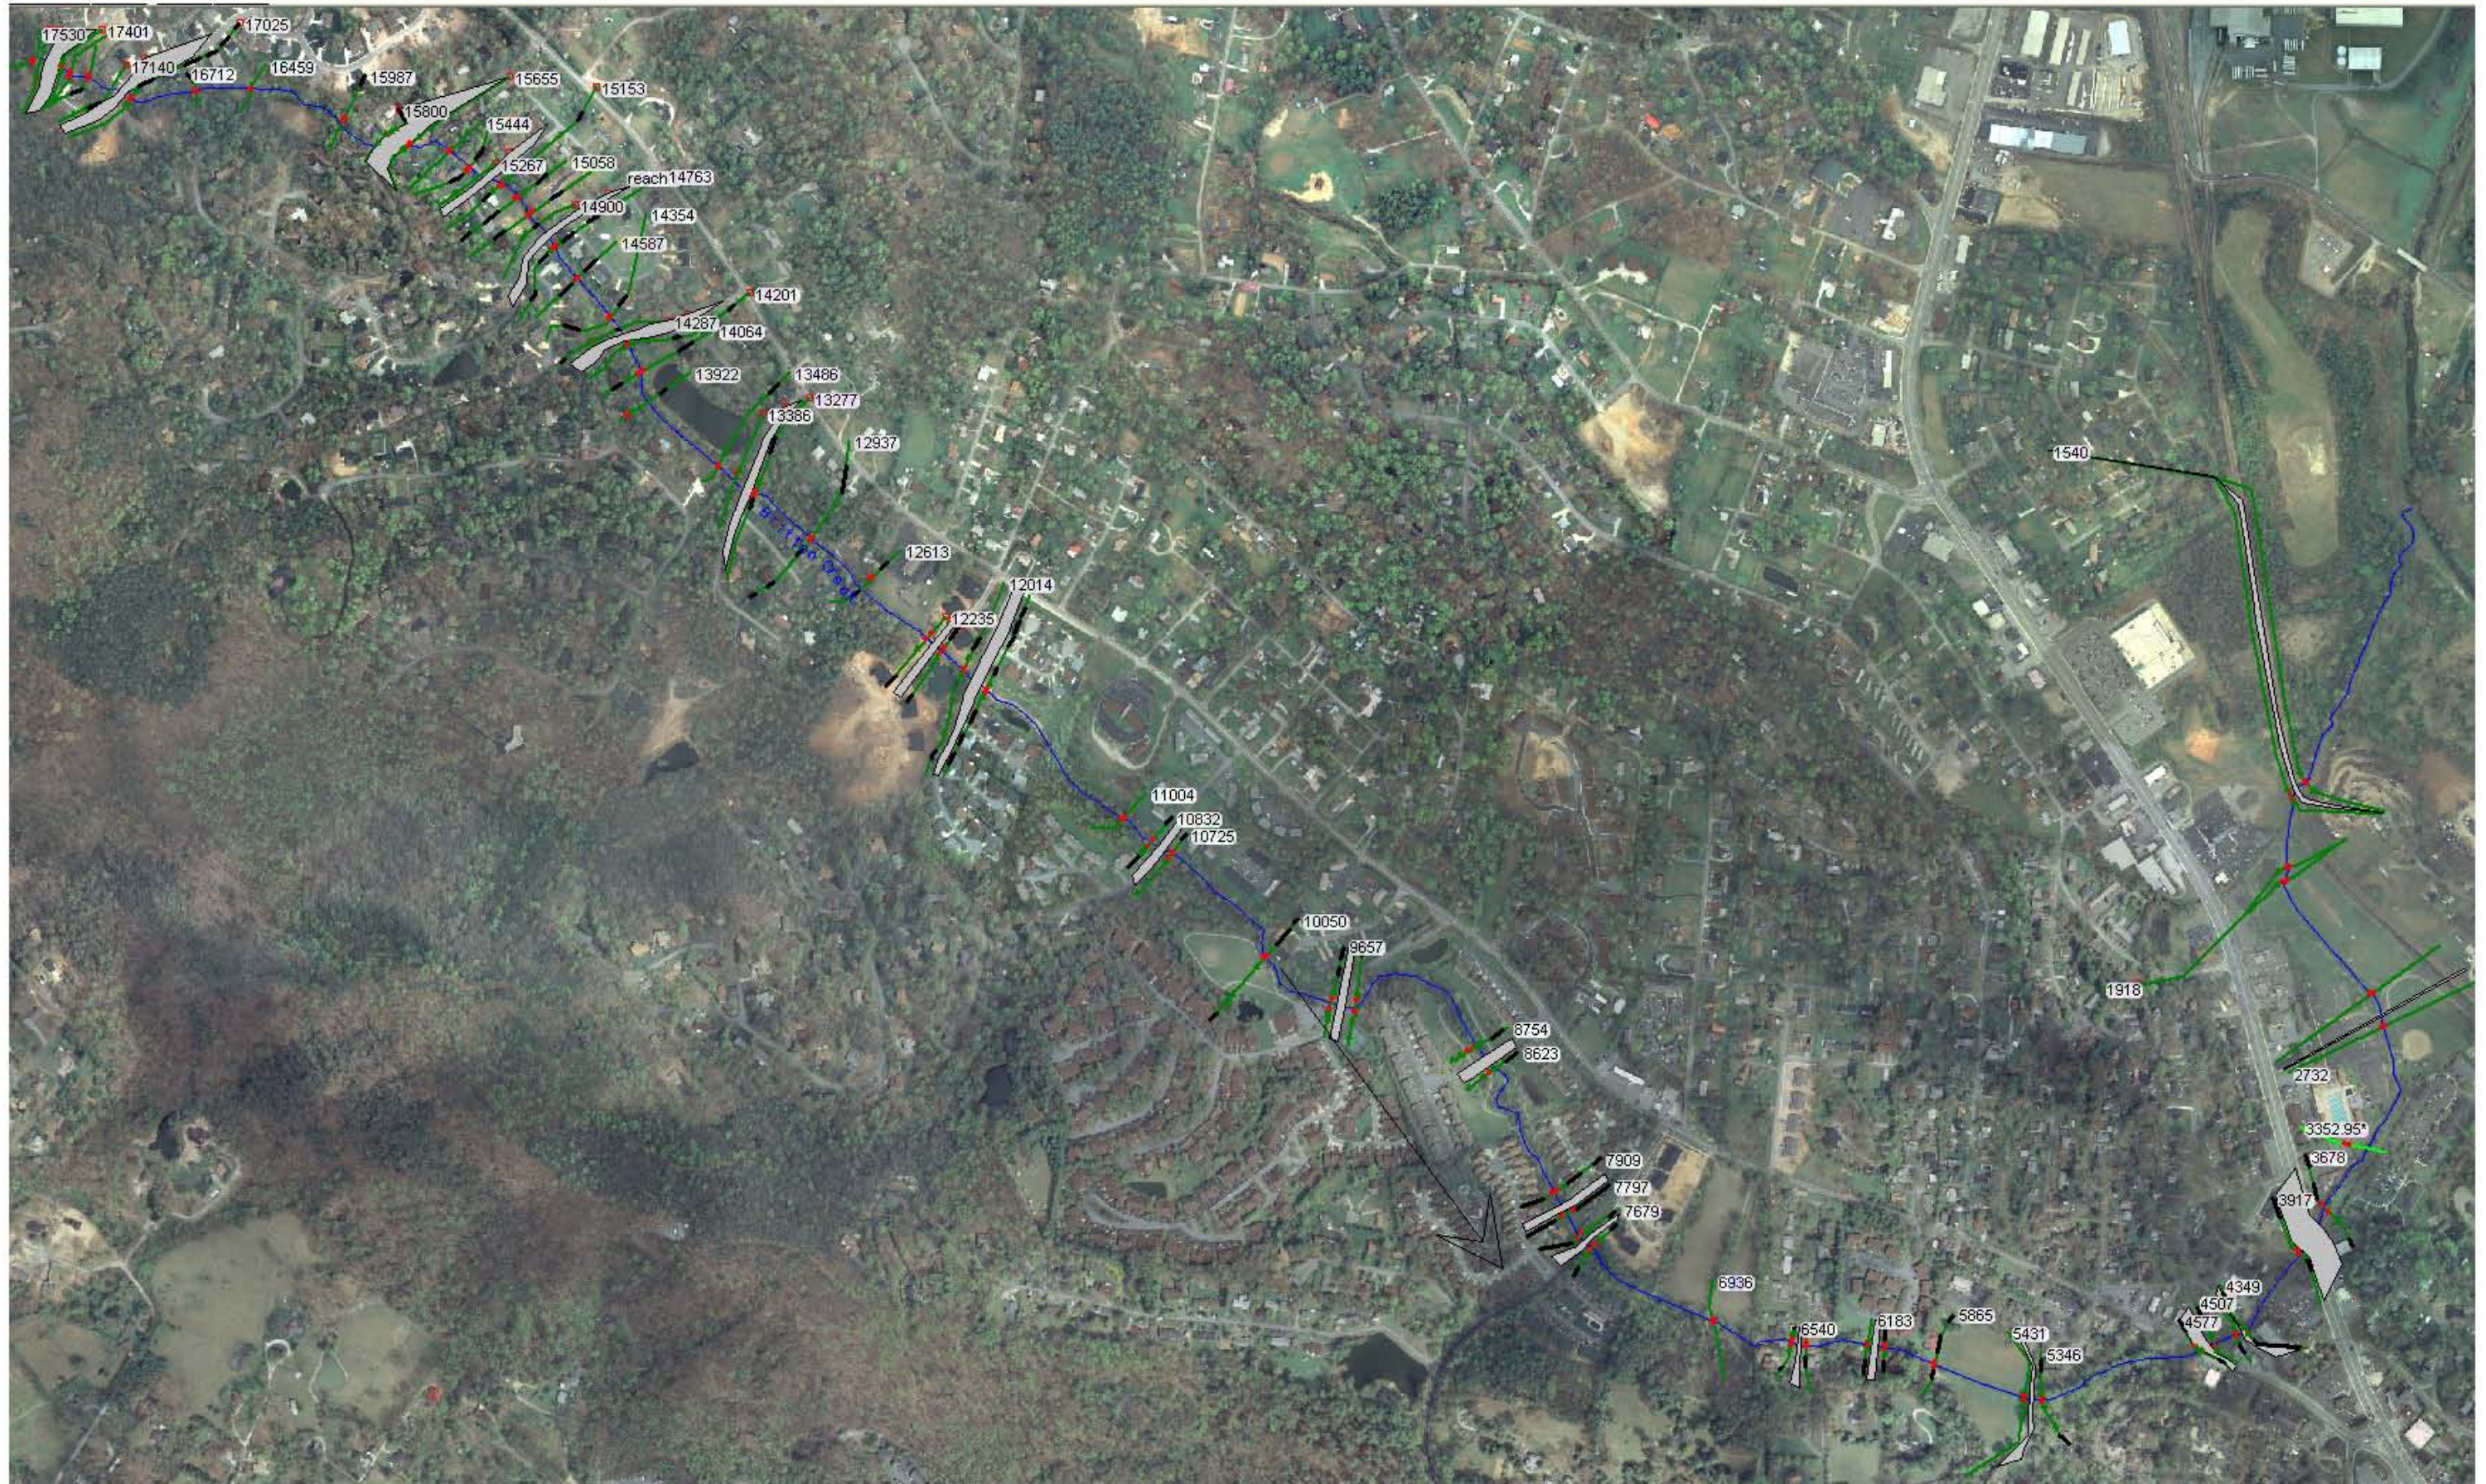
FIGURE 4.4: SCREEN SHOT OF HEC-RAS GEOMETRY FOR BRITTON CREEK. NUMBERED CROSS SECTIONS ARE GREEN. ROAD CROSSINGS ARE GREY. BANK STATIONS ARE RED. STRUCTURES IN CROSS SECTIONS ARE BLACK.

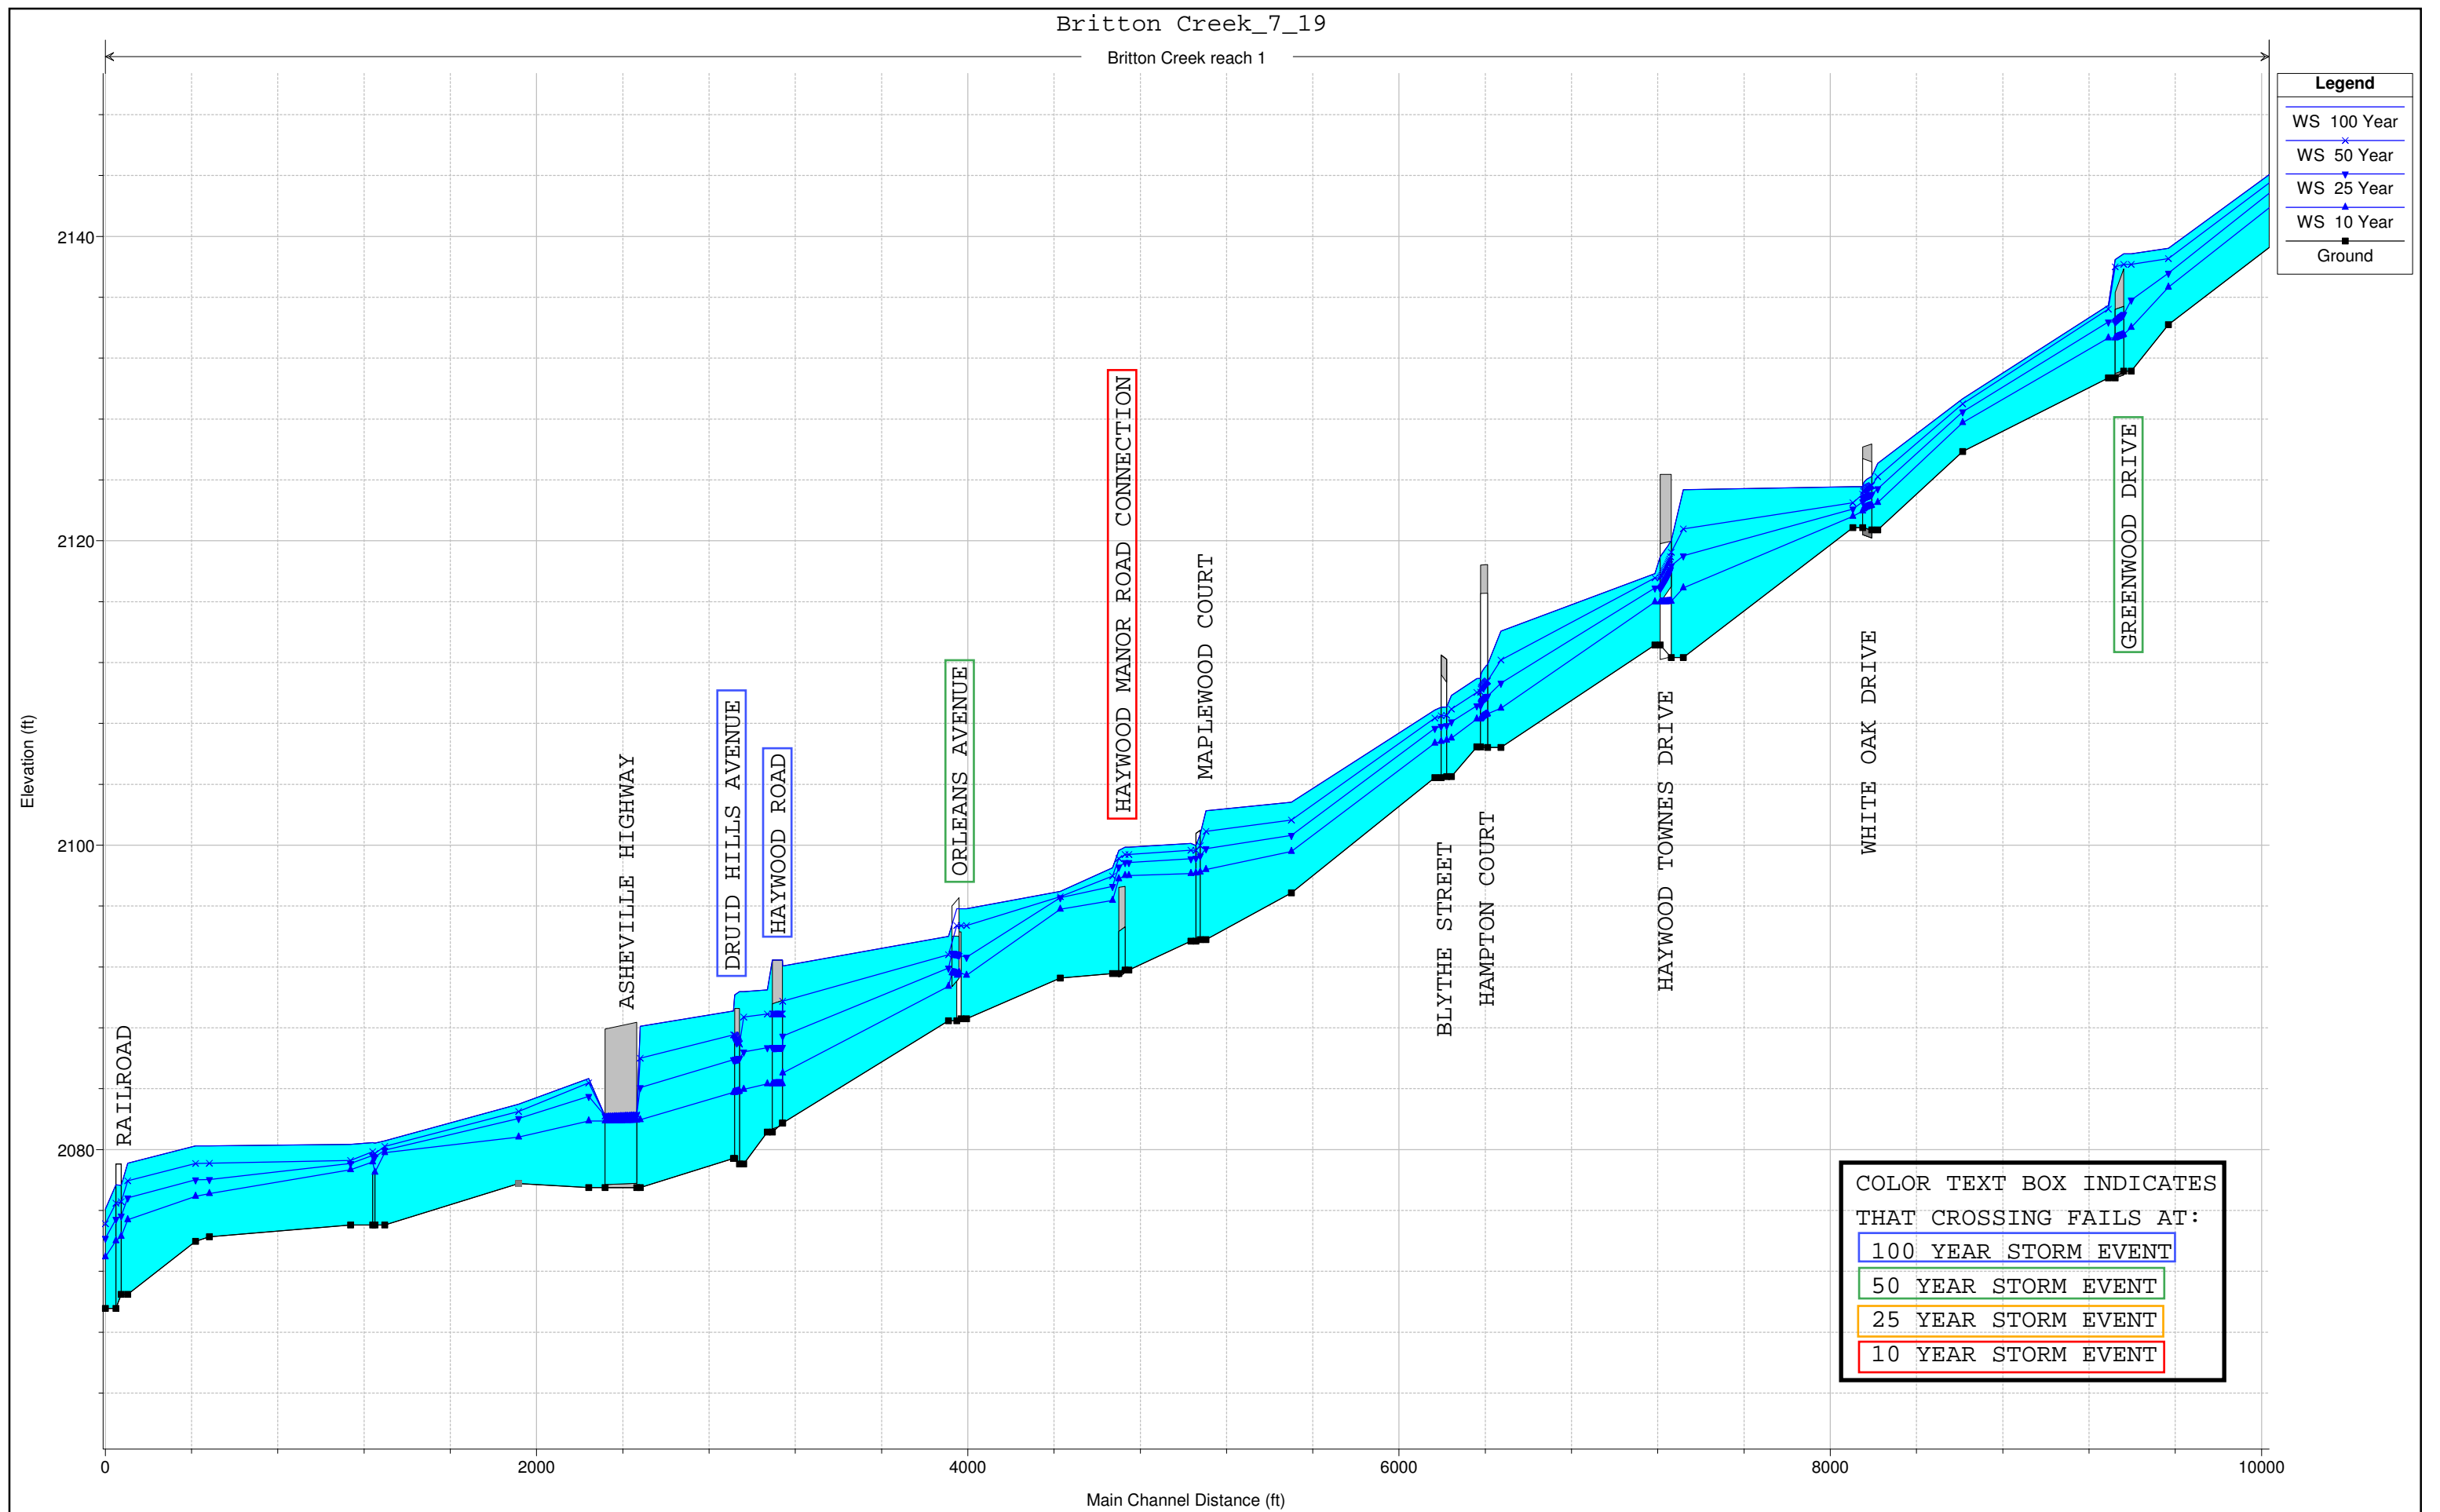
FIGURE 4.6: LOWER BRITTON CREEK PROFILE.

An analysis of the stream profiles for Britton Creek indicates the overtopping of nine culverts. Haywood Manor Road Connection is overtopped during the 10 year storm. Three more are overtopped during the 50 year storm event: Orleans Avenue, Greenwood Drive and Mistletoe Trail. Five more are overtopped during the 100 year event: Druid Hills Avenue, Haywood Road, Indian Hill Road, Long John Drive and Mistletoe Trail (there are two crossings of this road).

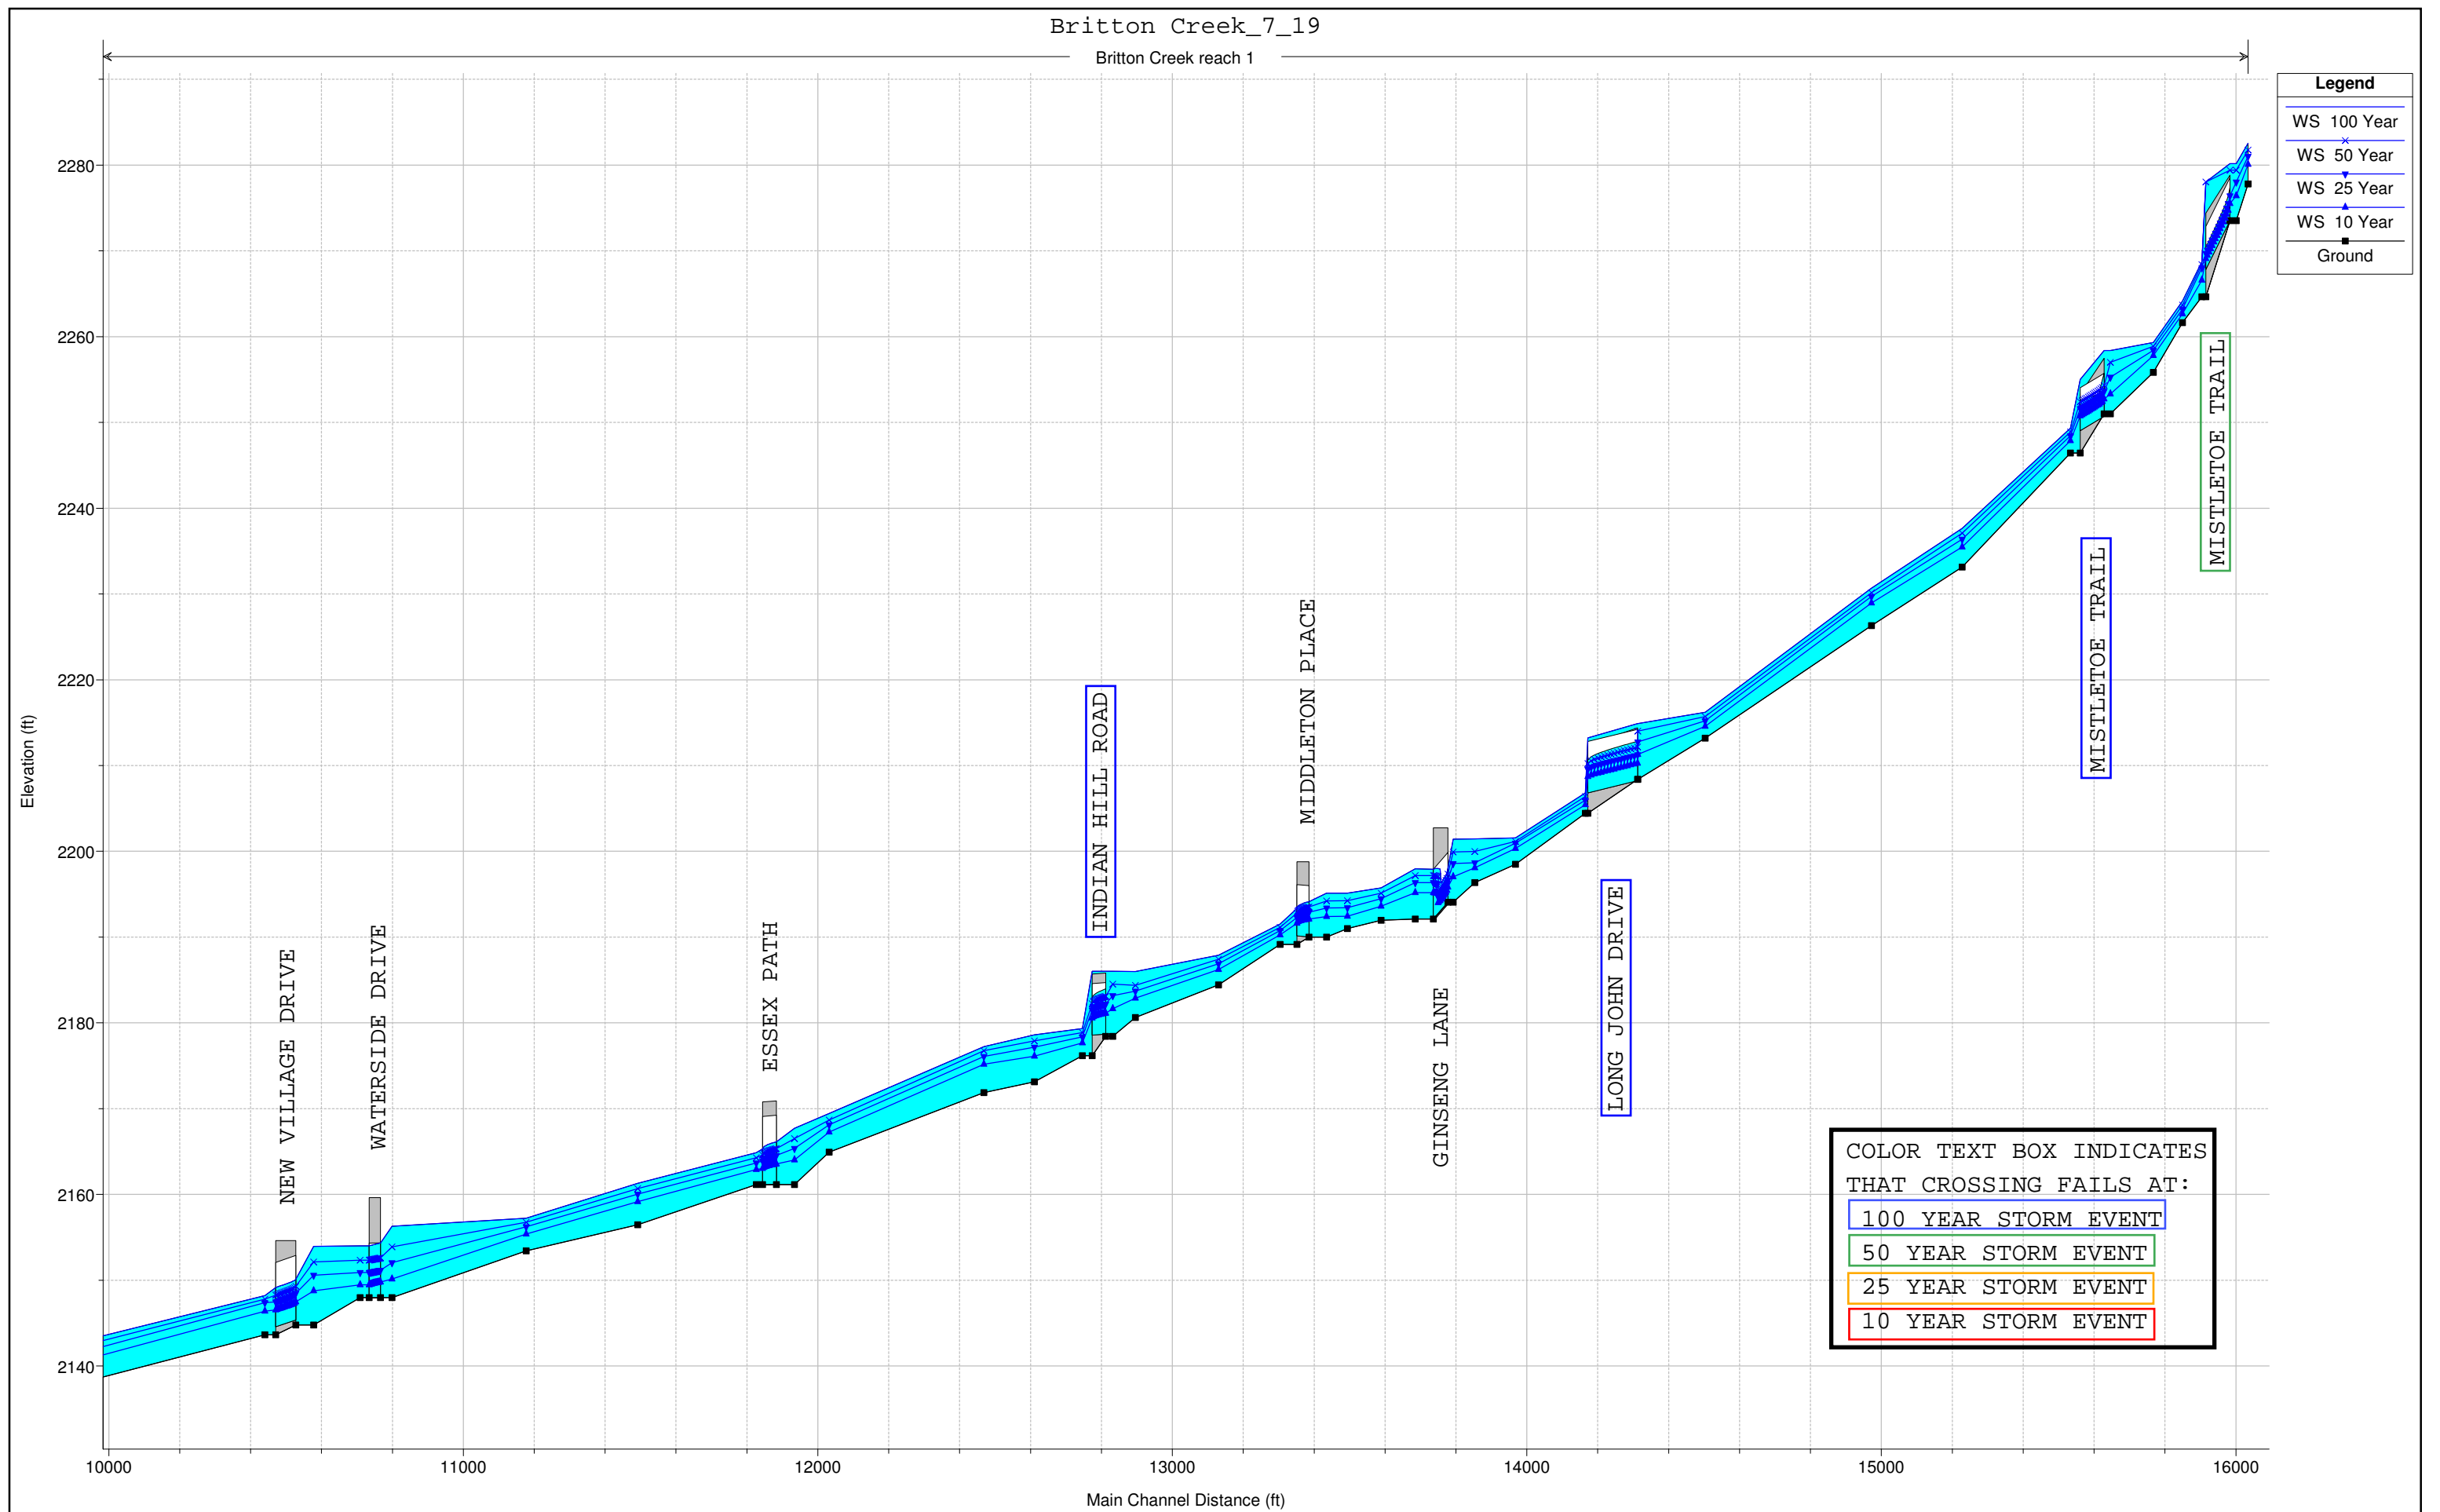
FIGURE 4.8: UPPER BRITTON CREEK PROFILE.

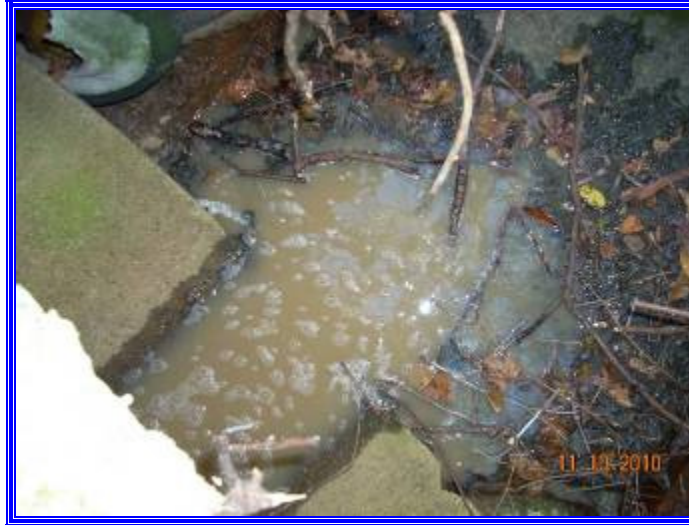
Figure 5.1: Sediment Discharge at Hendersonville Elementary.

Sediment, although a significant source of pollution in both streams, was not traceable directly to its source. During the days of field visits, the stream flow was moderate and suspended sediment was not generally visible in the stream (the exception is shown in Figure 5.1).
