**BRITTON CREEK
STORMWATER MASTER PLAN**

**CITY OF HENDERSONVILLE
HENDERSON COUNTY, NORTH CAROLINA**

June, 2011

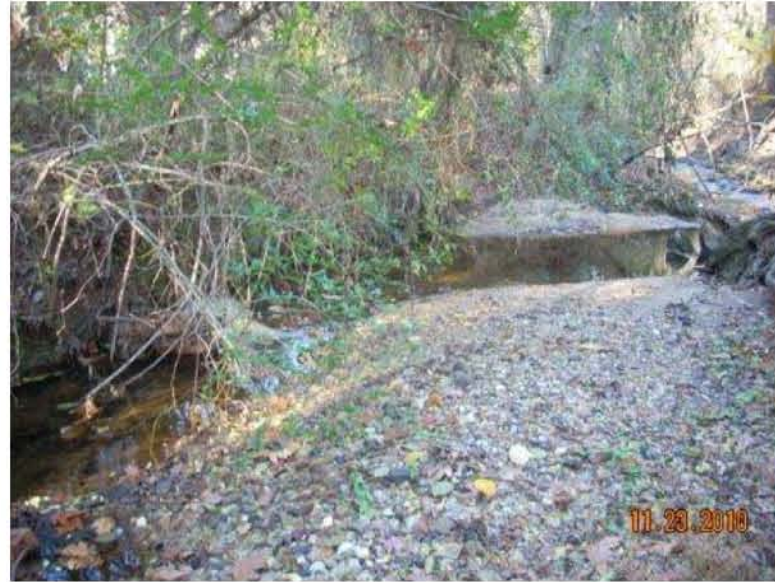
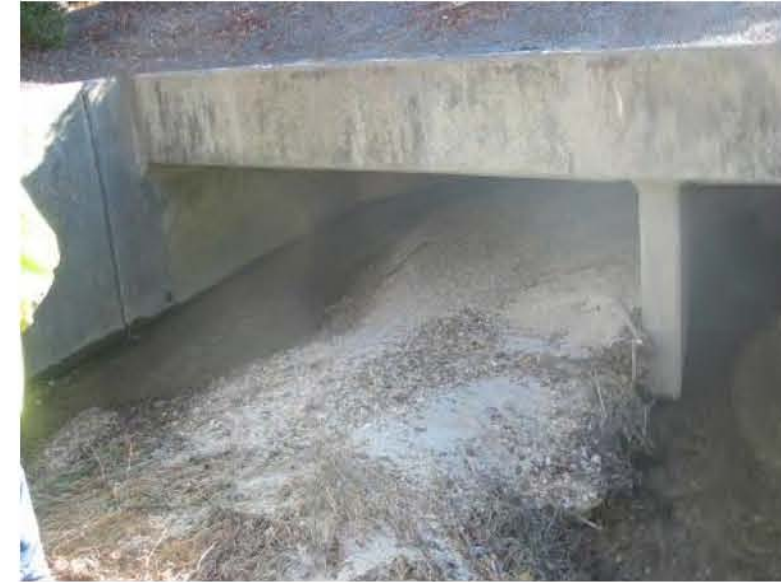
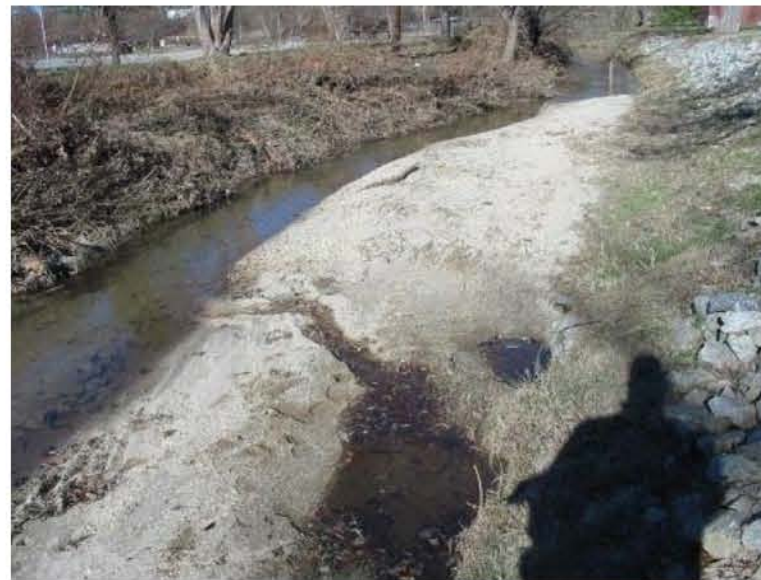
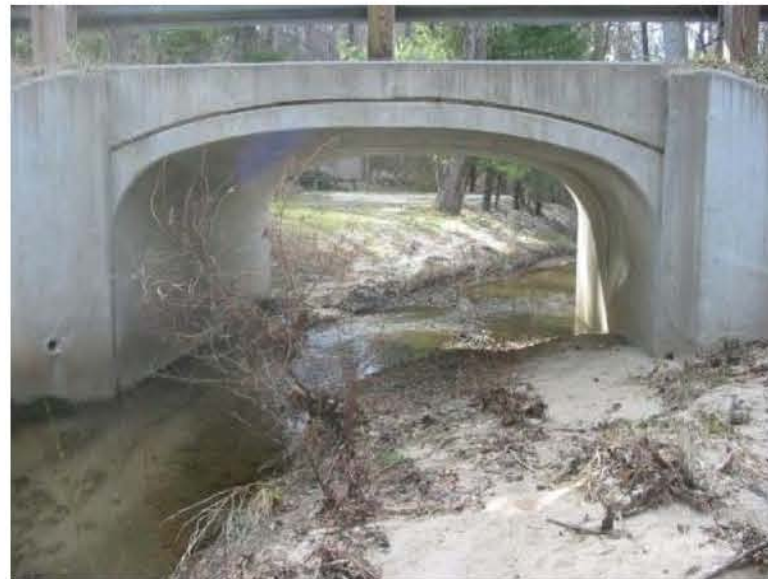
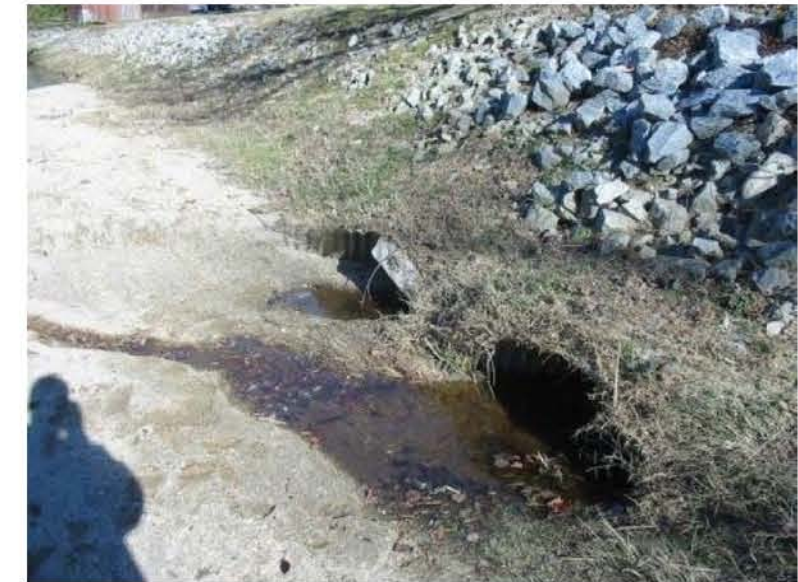
FIGURE 5.3: PHOTOS OF SEDIMENT DEPOSITION

BRITTON CREEK JUST DOWNSTREAM OF GREENWOOD DRIVE

BRITTON CREEK JUST DOWNSTREAM OF ASHEVILLE HIGHWAY

BRITTON CREEK JUST UPSTREAM OF MAPLEWOOD COURT

However, deposited sediment was readily visible throughout both streams. Figures 5.2-5.3 illustrate ten locations of particularly heavy sediment deposition. Several sources of the sediment loads were identified through inference because of obvious stream bank undercutting and sediment loss. Figures 5.4-5.5 illustrate the areas where major erosion problems were identified.

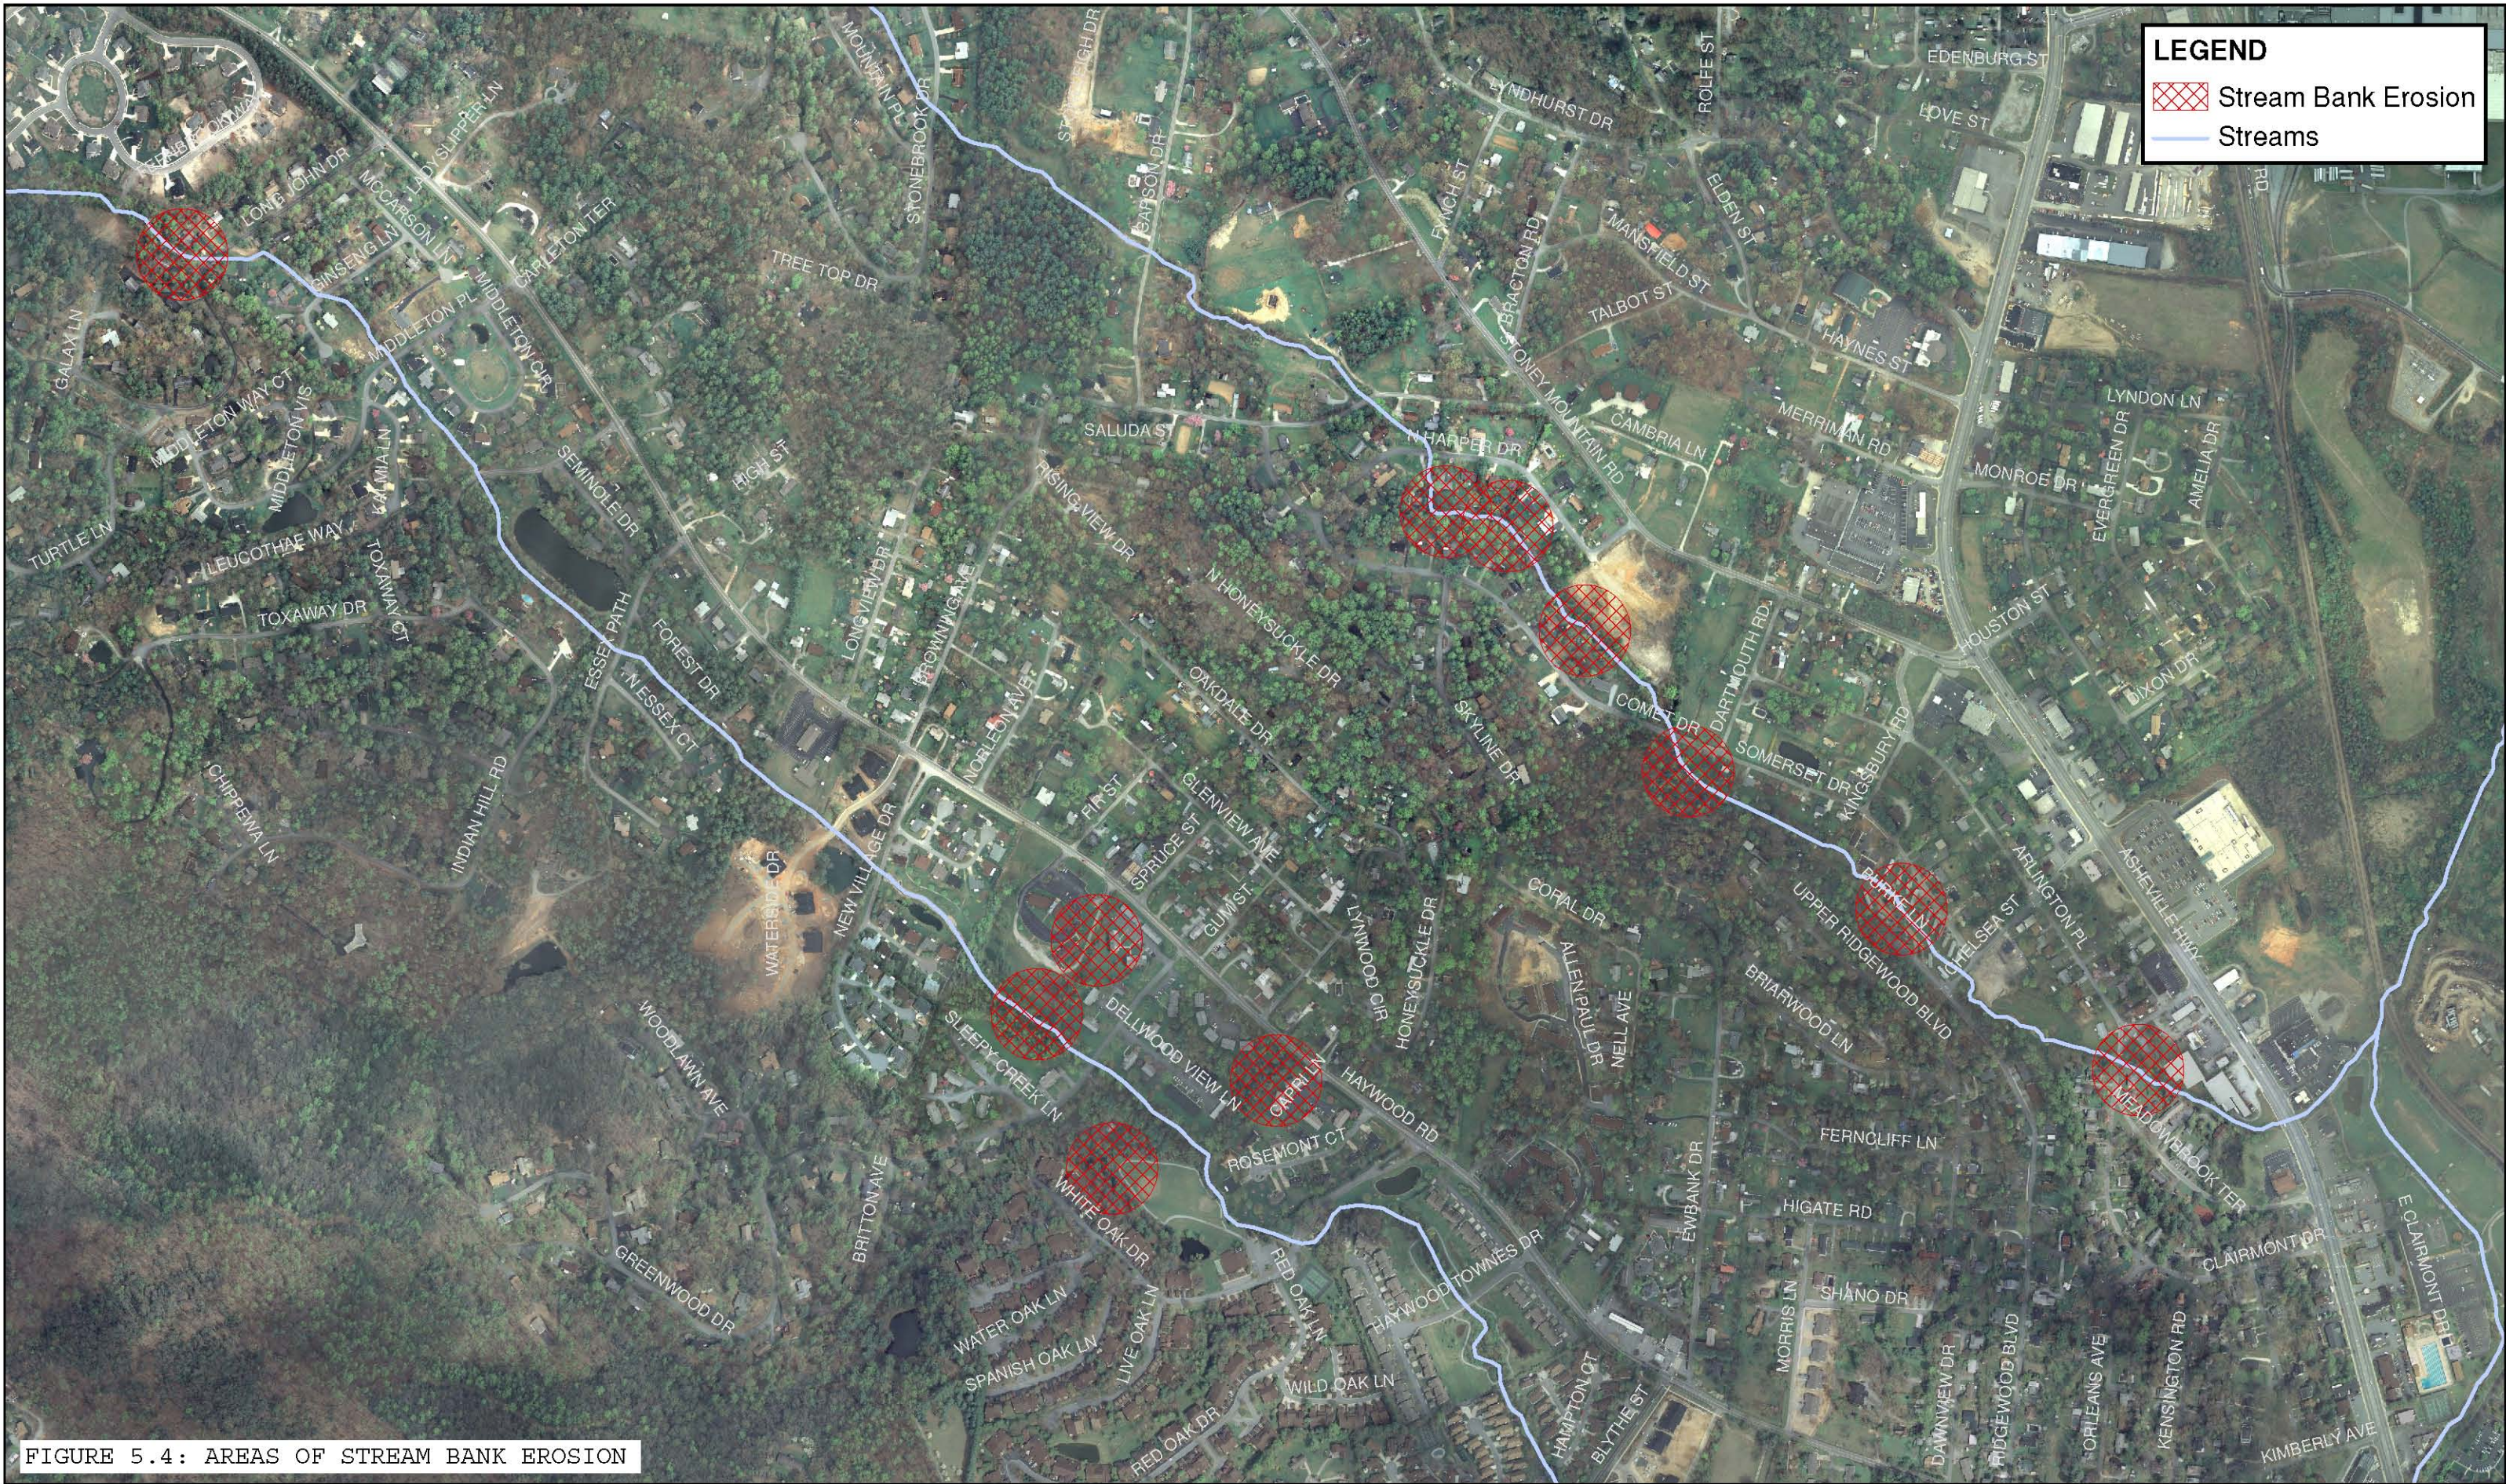
FIGURE 5.4: AREAS OF STREAM BANK EROSION

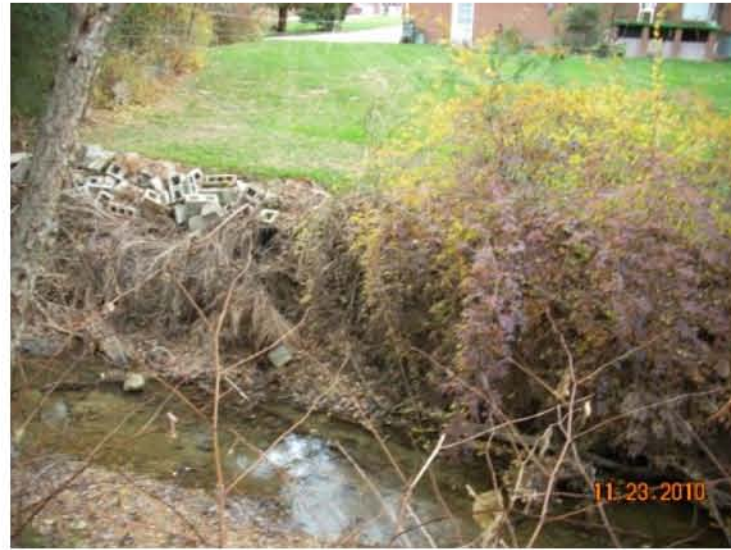
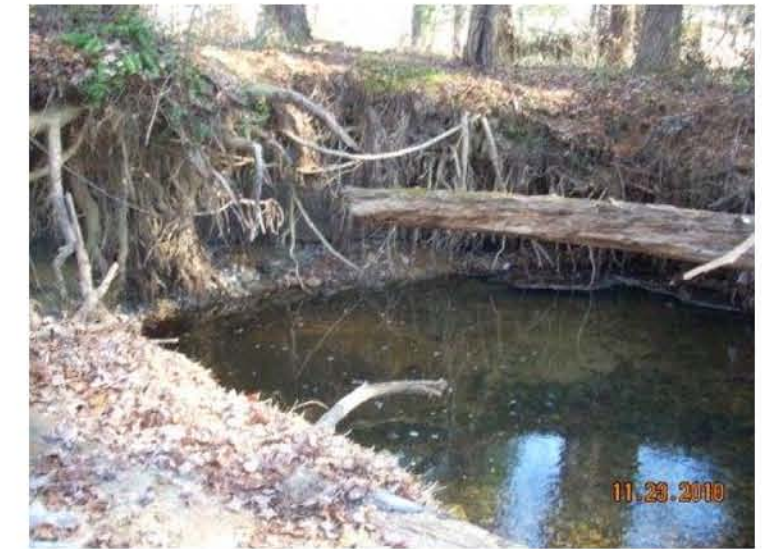
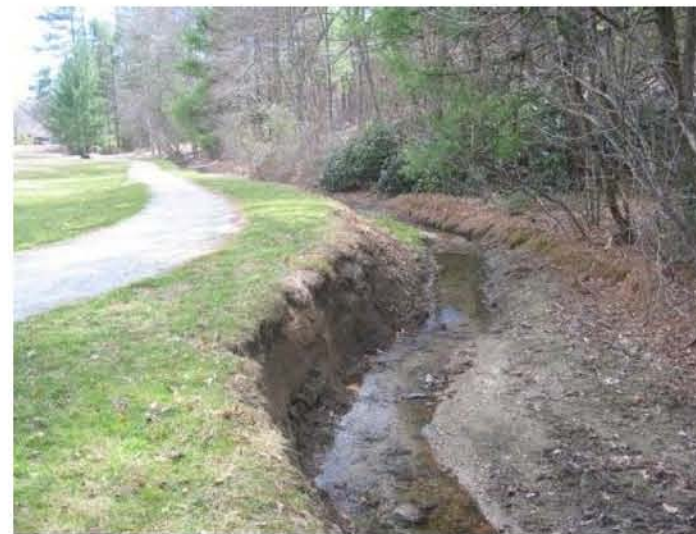
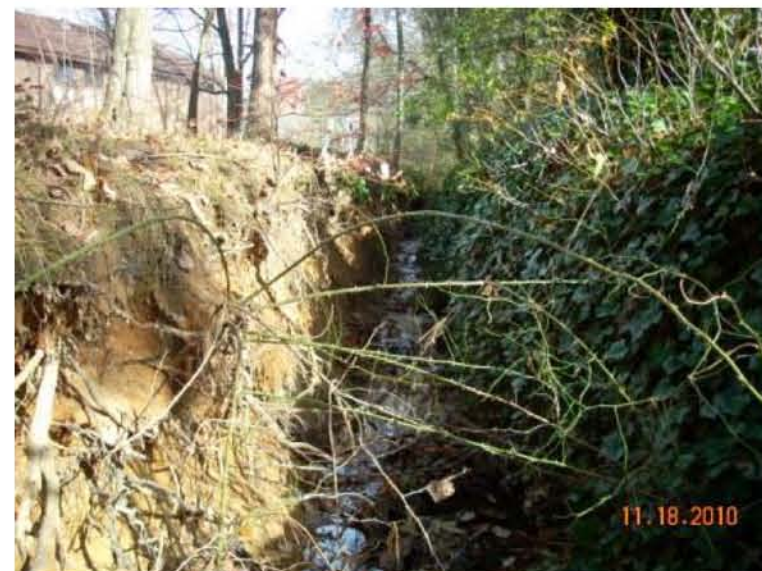
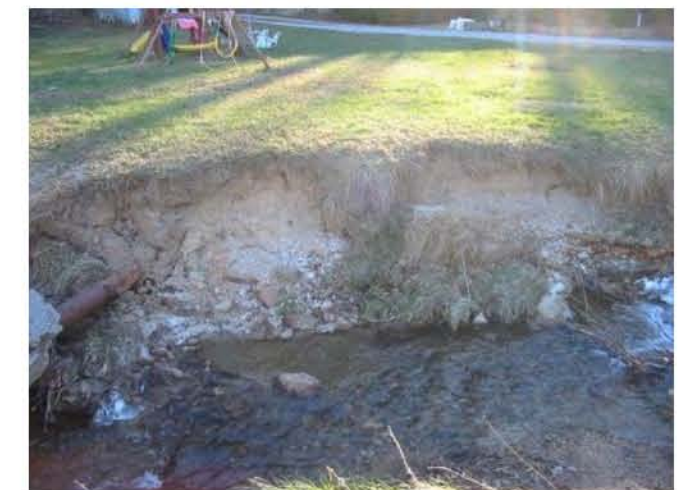
FIGURE 5.5: PHOTOS OF STREAM BANK EROSION

TRIBUTARY 2 DOWNSTREAM OF NORTH HARPER DRIVE

BRITTON CREEK UPSTREAM OF GREENWOOD DRIVE

SMALL TRIBUTARY TO BRITTON CREEK NEAR 'THE OAKS'

BRITTON CREEK UPSTREAM OF ORLEANS AVENUE

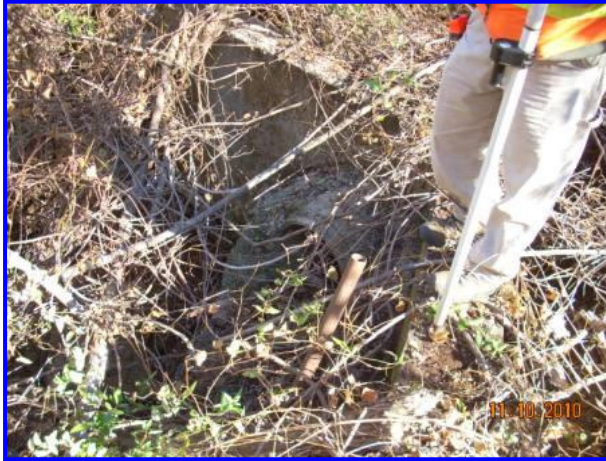
Figure 5.7: Headwall at Hendersonville Elementary.

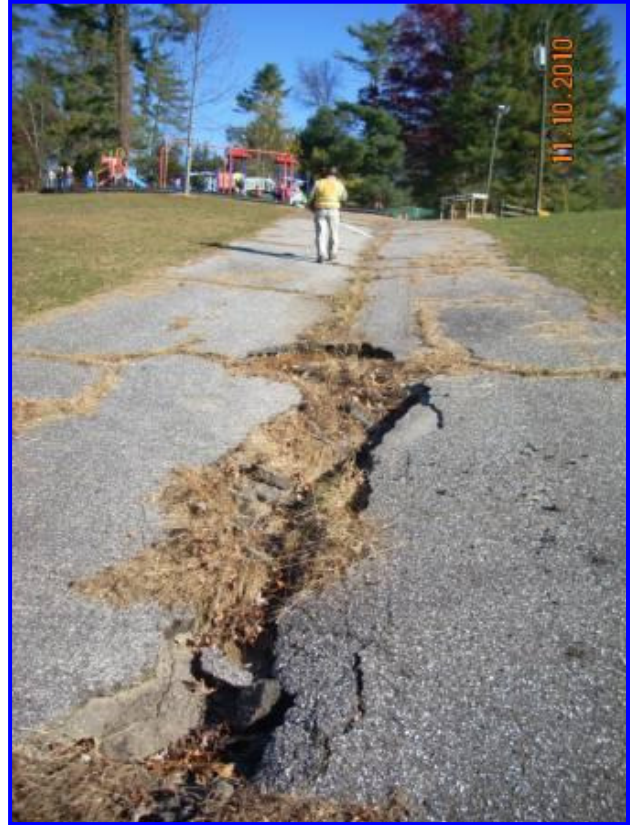
Figure 5.8: Asphalt Swale at Hendersonville Elementary.

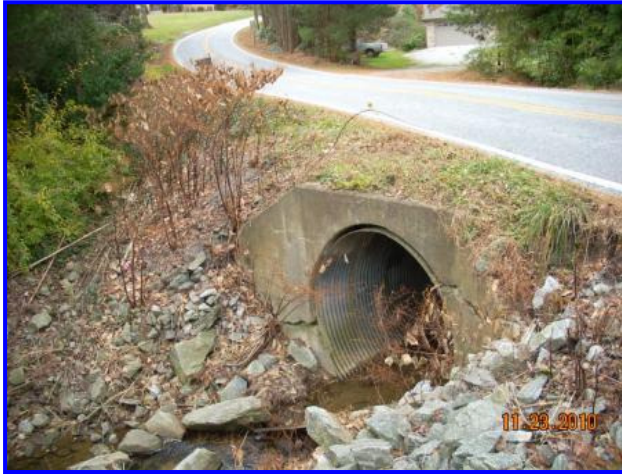
Figure 5.9: Headwall Browning Avenue.

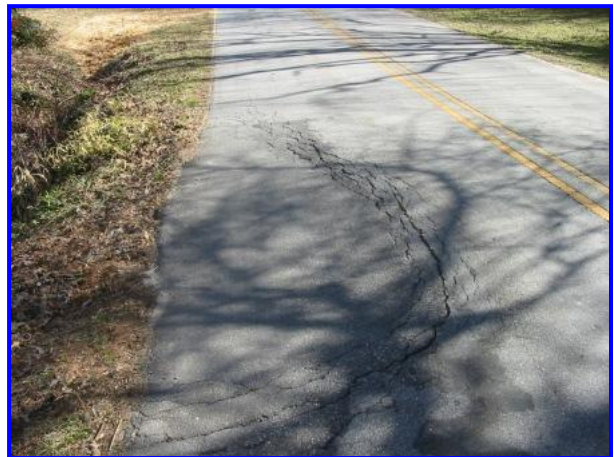
Figure 5.10: Sinking Asphalt on Long John Drive.

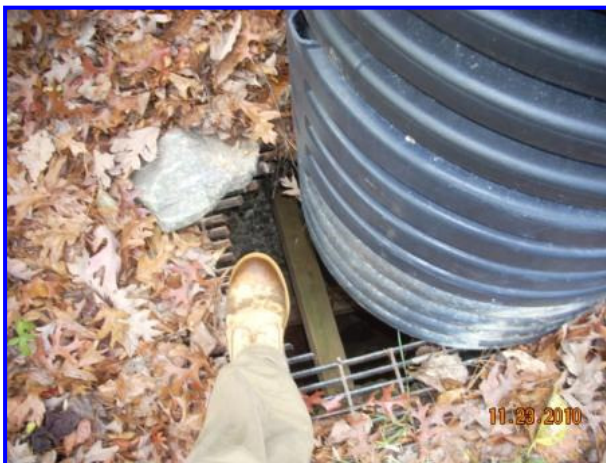
Figure 5.11: Open Grate Inlet Burke Lane.

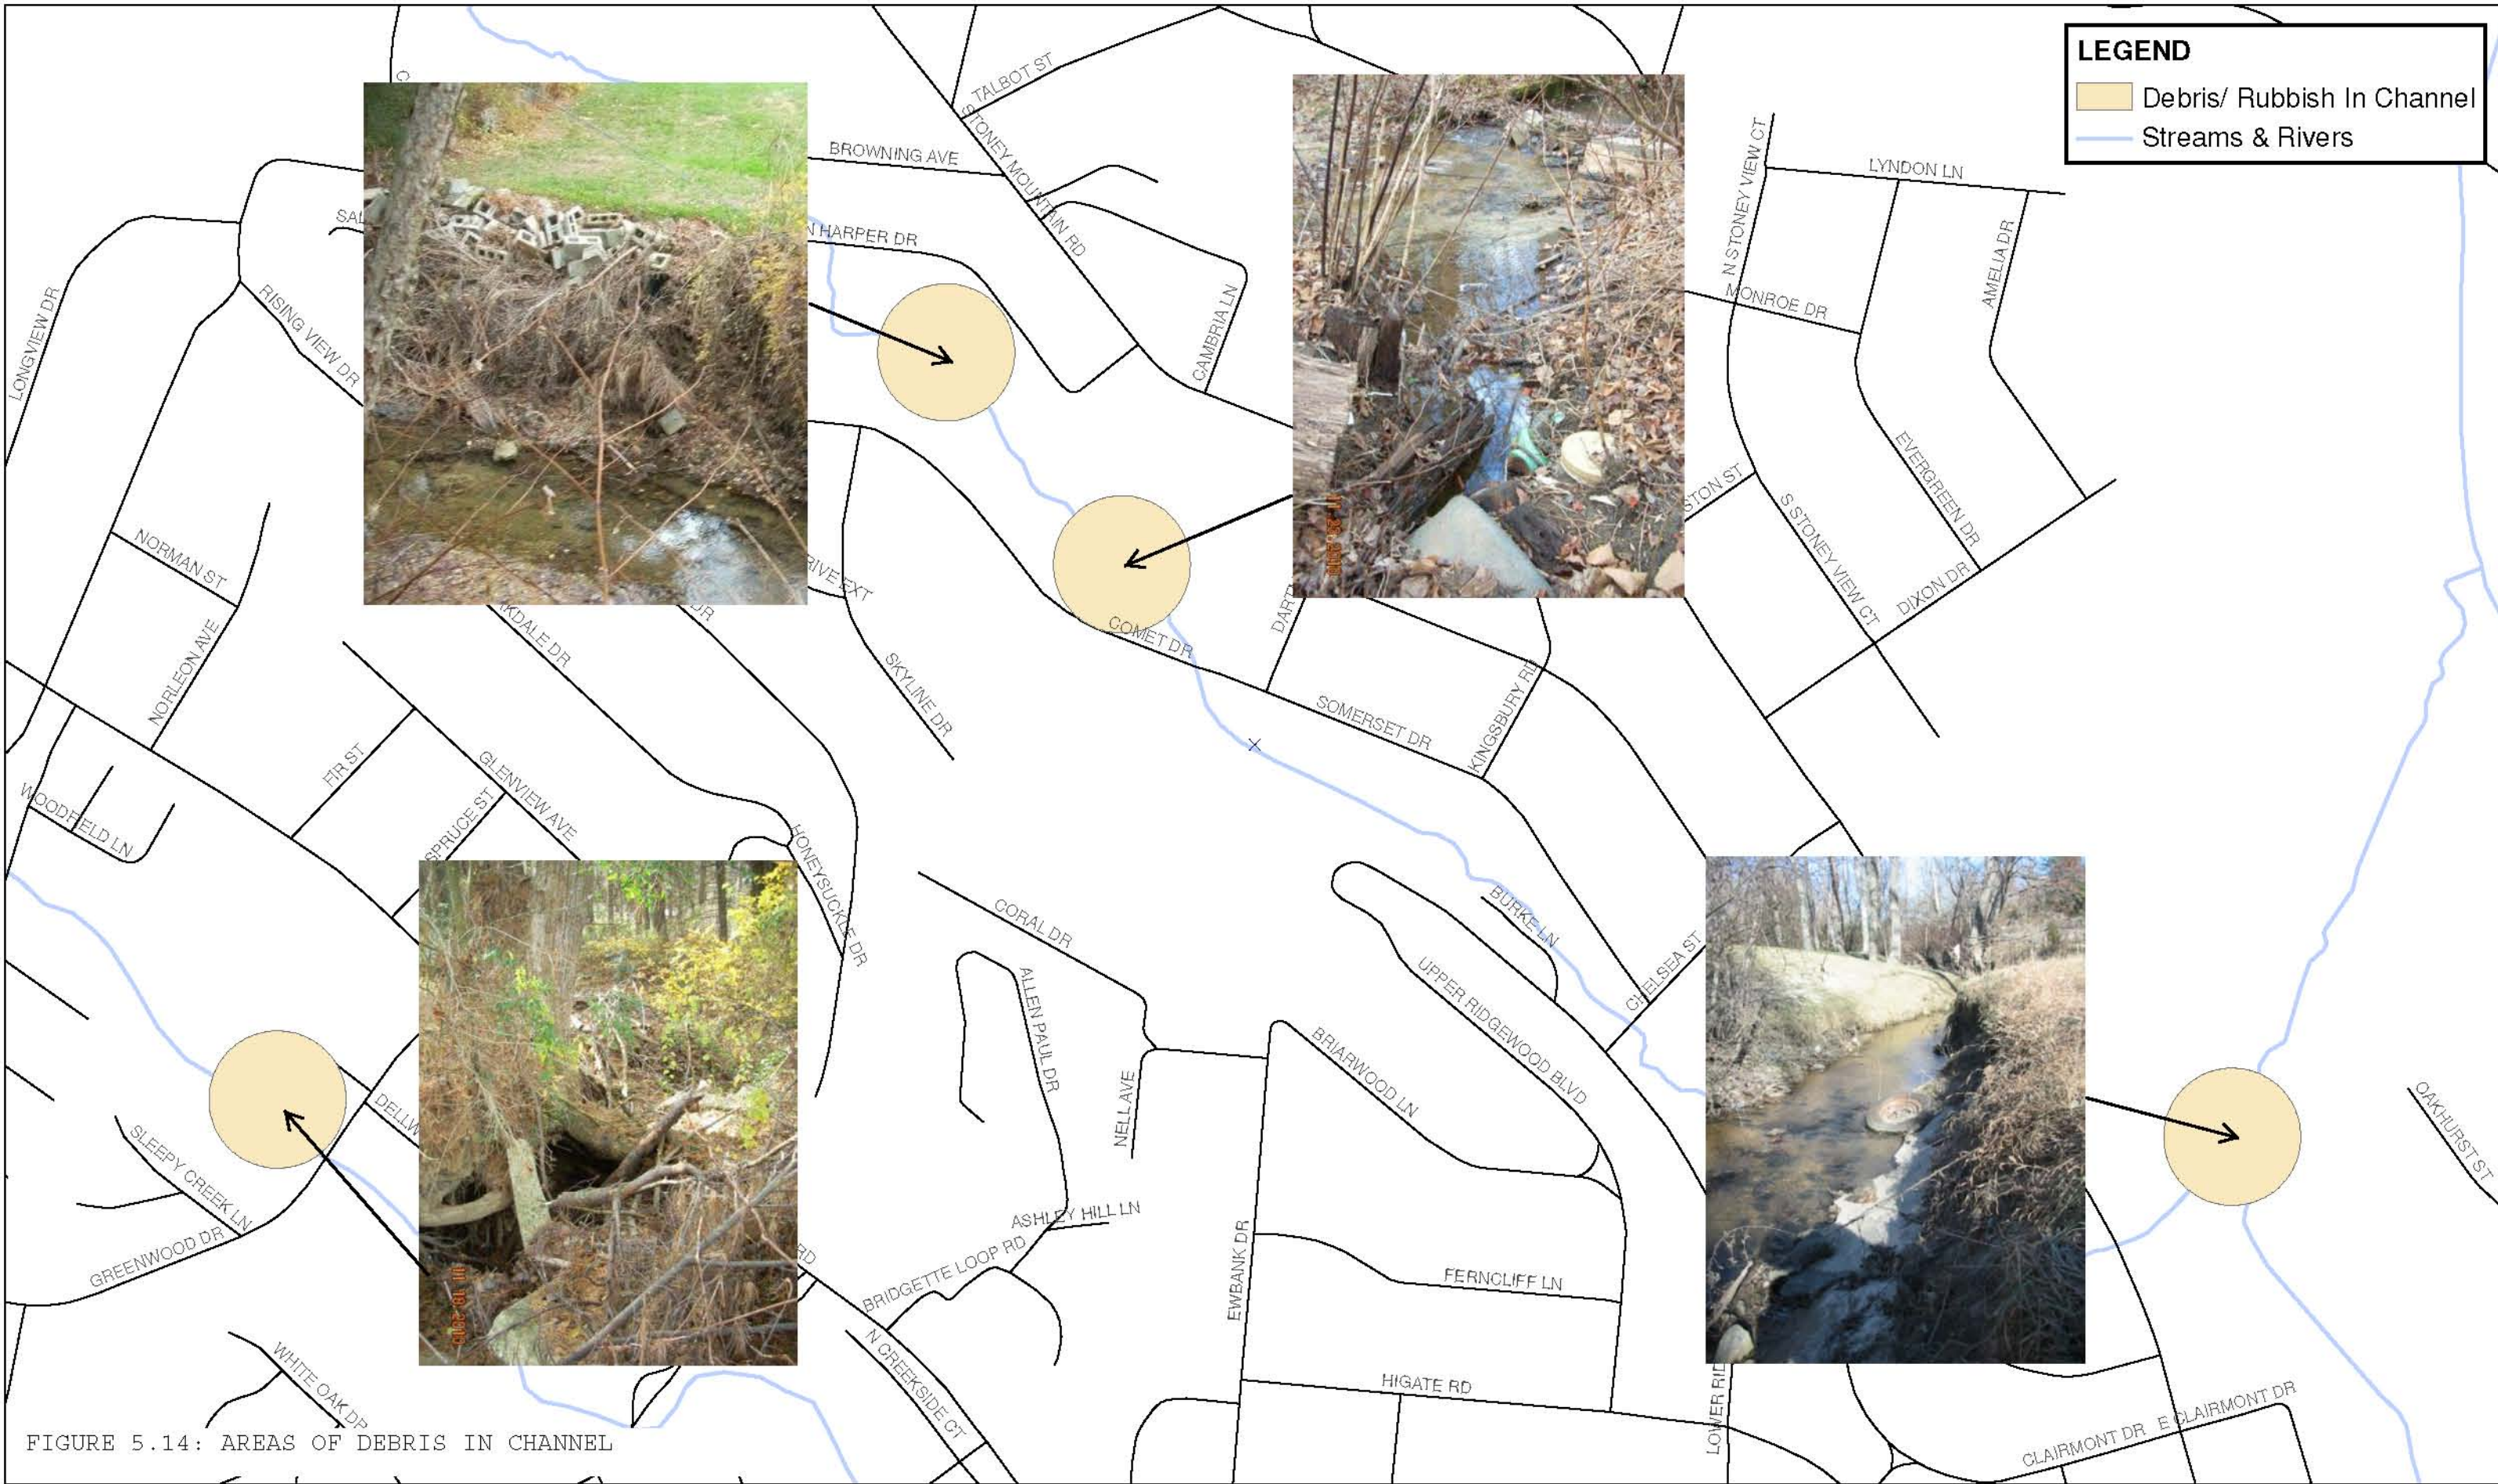
FIGURE 5.14: AREAS OF DEBRIS IN CHANNEL

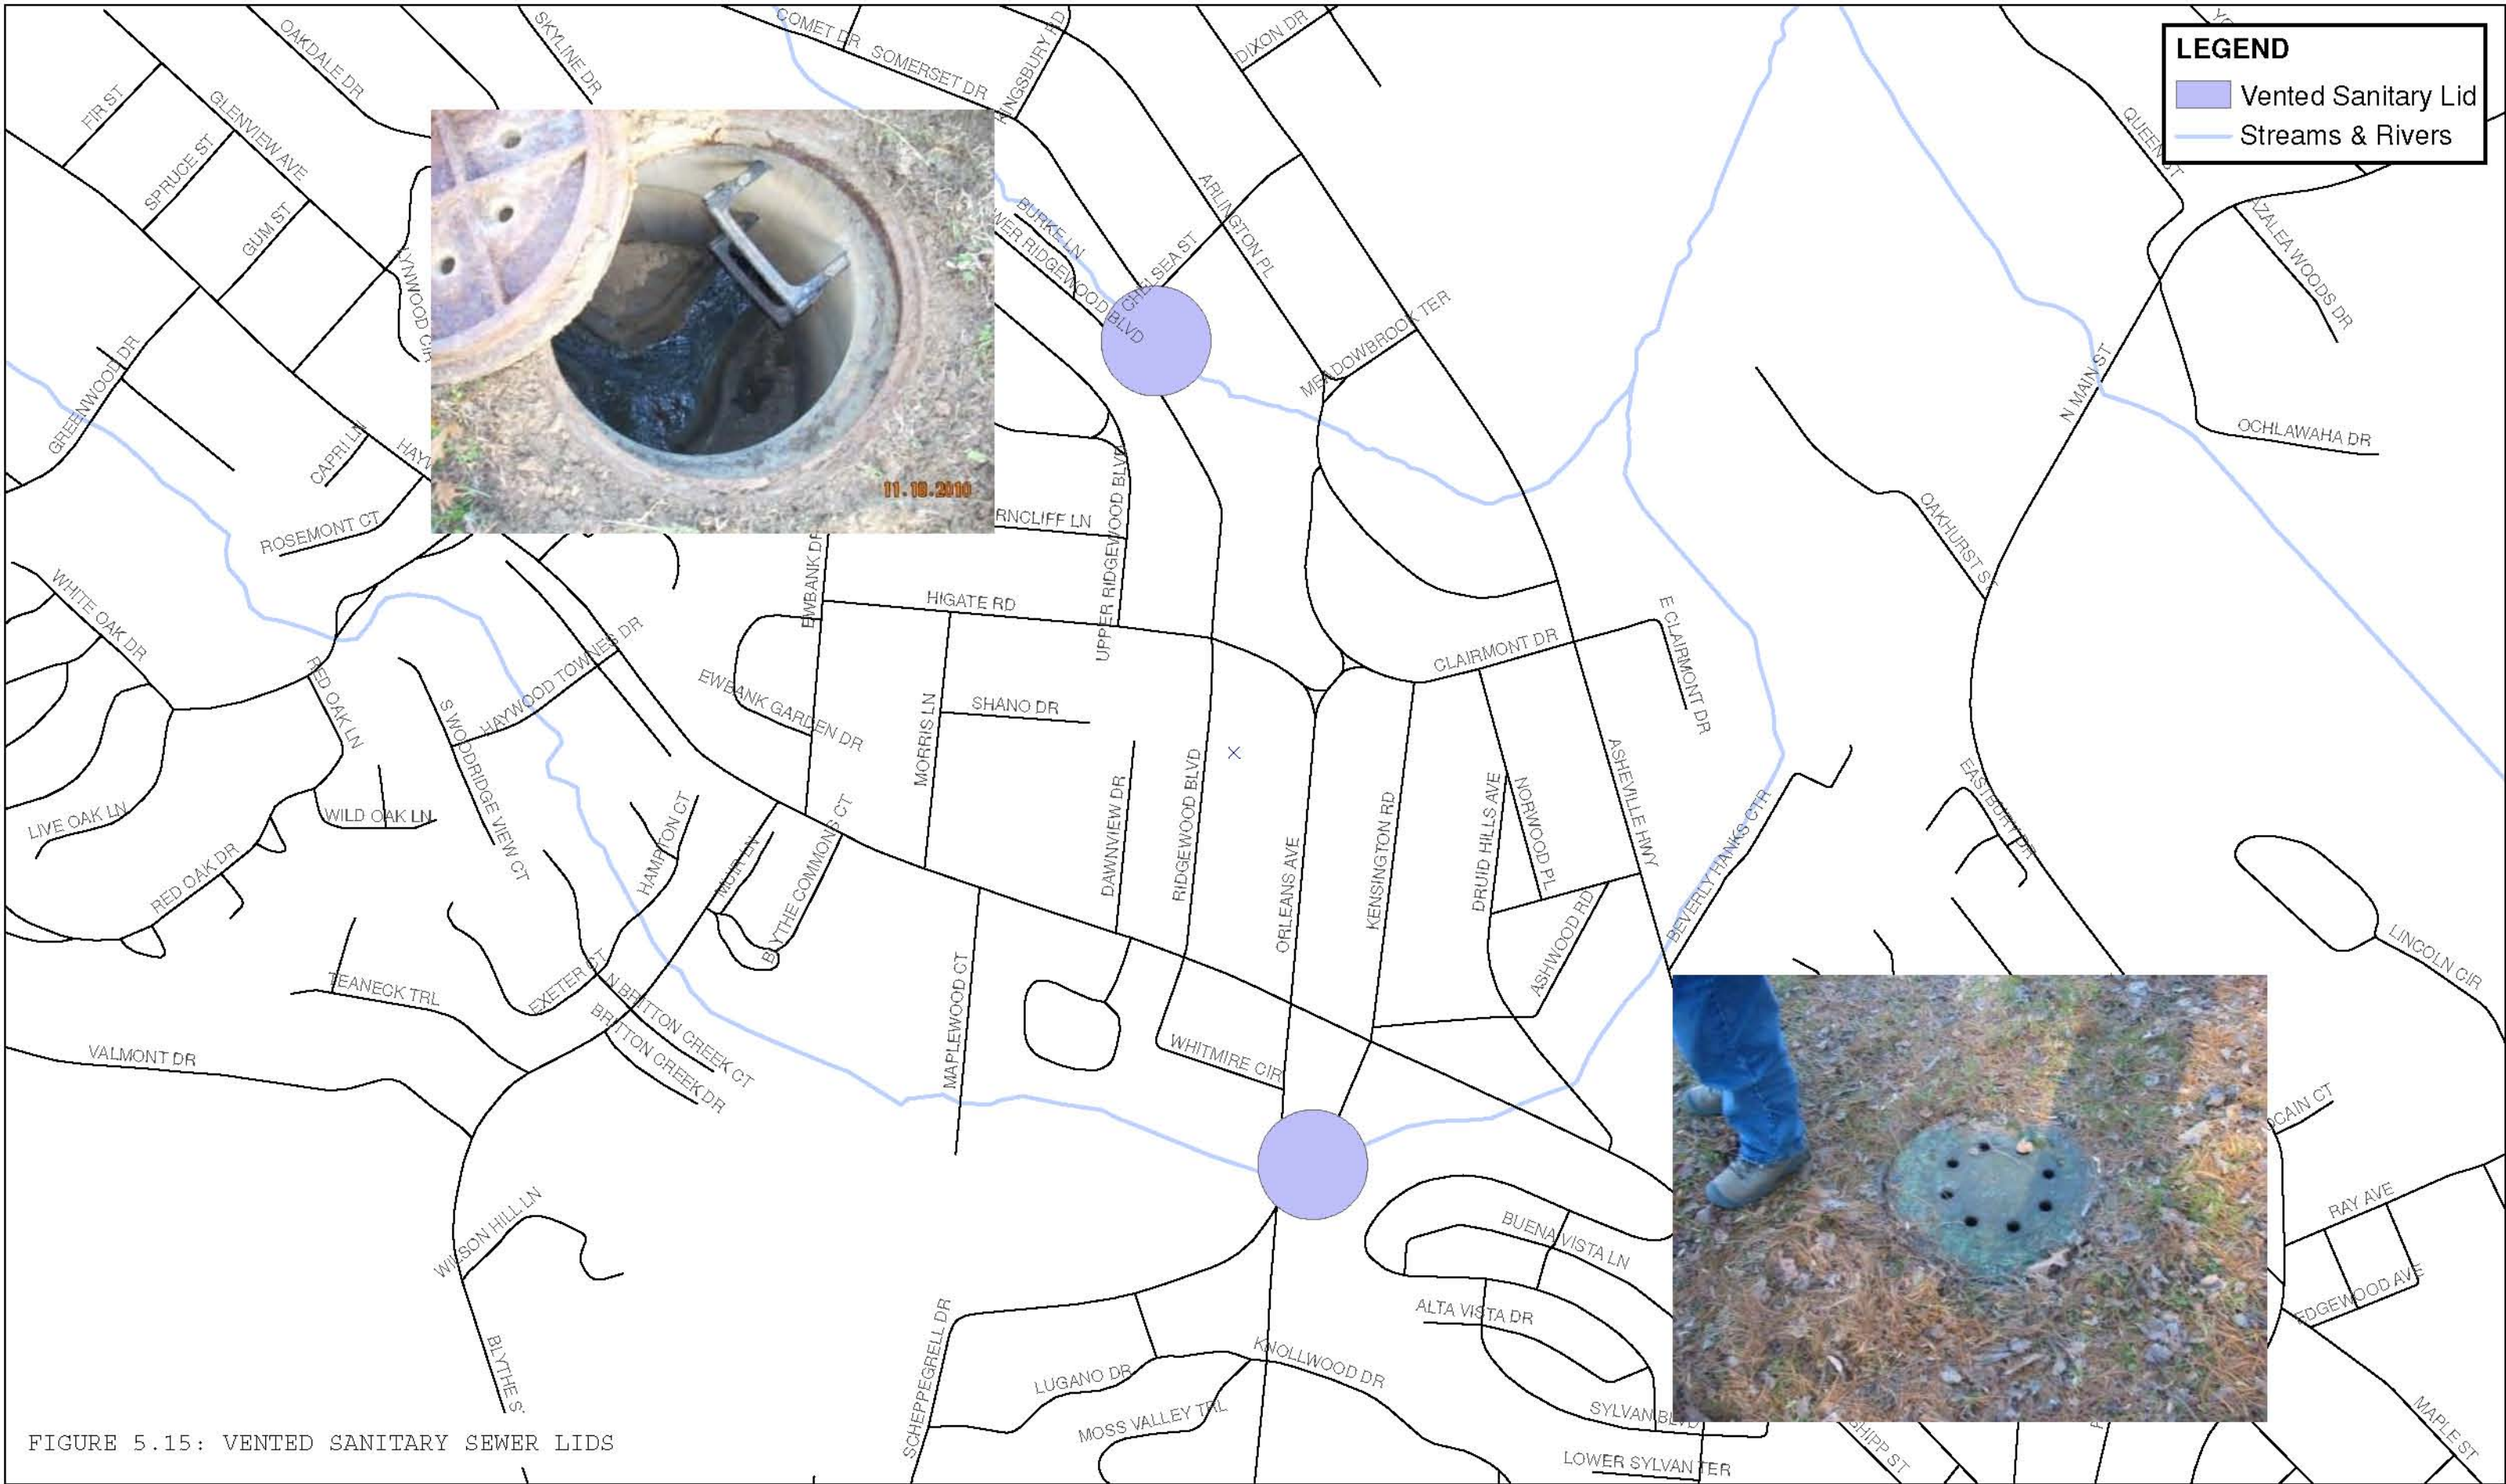
FIGURE 5.15: VENTED SANITARY SEWER LIDS

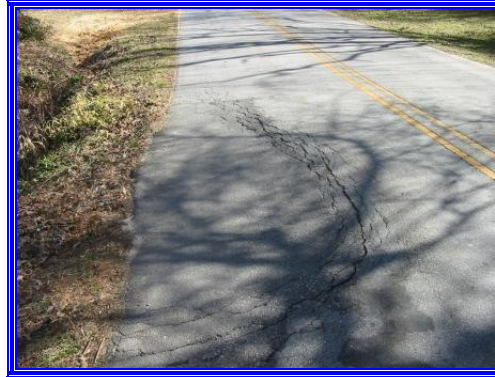
Figure 5.16: Sinking Asphalt on Long John Drive.

drainage ditch which feeds into a drainage pipe. The ditch and pipe are so obstructed with leaves that field personnel were unable to locate the pipe. On February 22, 2011, field personnel surveying on Long John Drive were addressed by a driver of a passing car. He stated that he had observed that the asphalt roadway directly above the 2 foot CMP culvert had sunk. A photo of the road is shown in Figure 5.16.

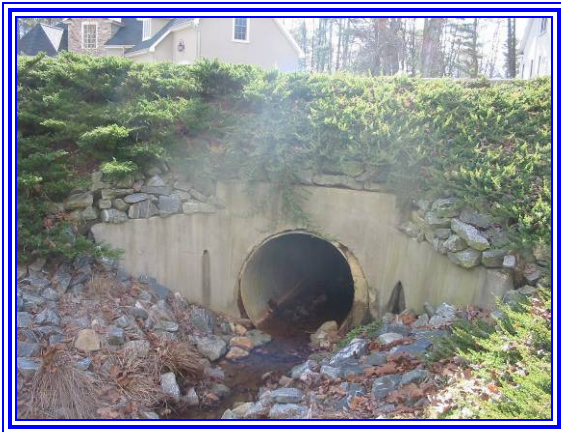
Figure 7.1: Enclosed Culvert (Mistletoe Trail)

Culvert replacements are recommended to be single-span, reinforced concrete structures with a natural bottom. These three sided structures are not only more hydraulically efficient than multiple pipes at each crossing, but also more environmentally friendly and require less maintenance. Figures 7.1 and 7.2 illustrate the difference in the streams' general health and condition when an enclosed culvert is used compared to when a bottomless culvert used.

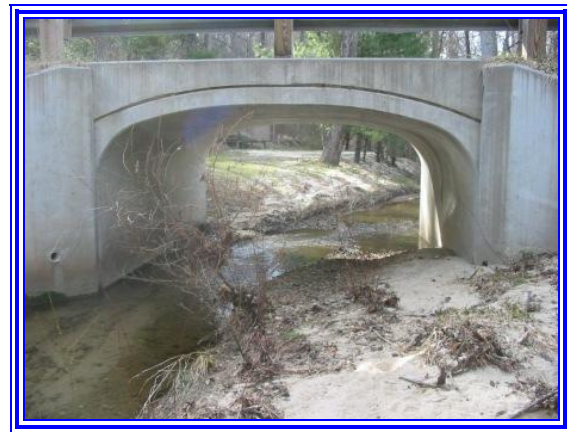
Figure 7.2: Bottomless Culvert (Maplewood Court)

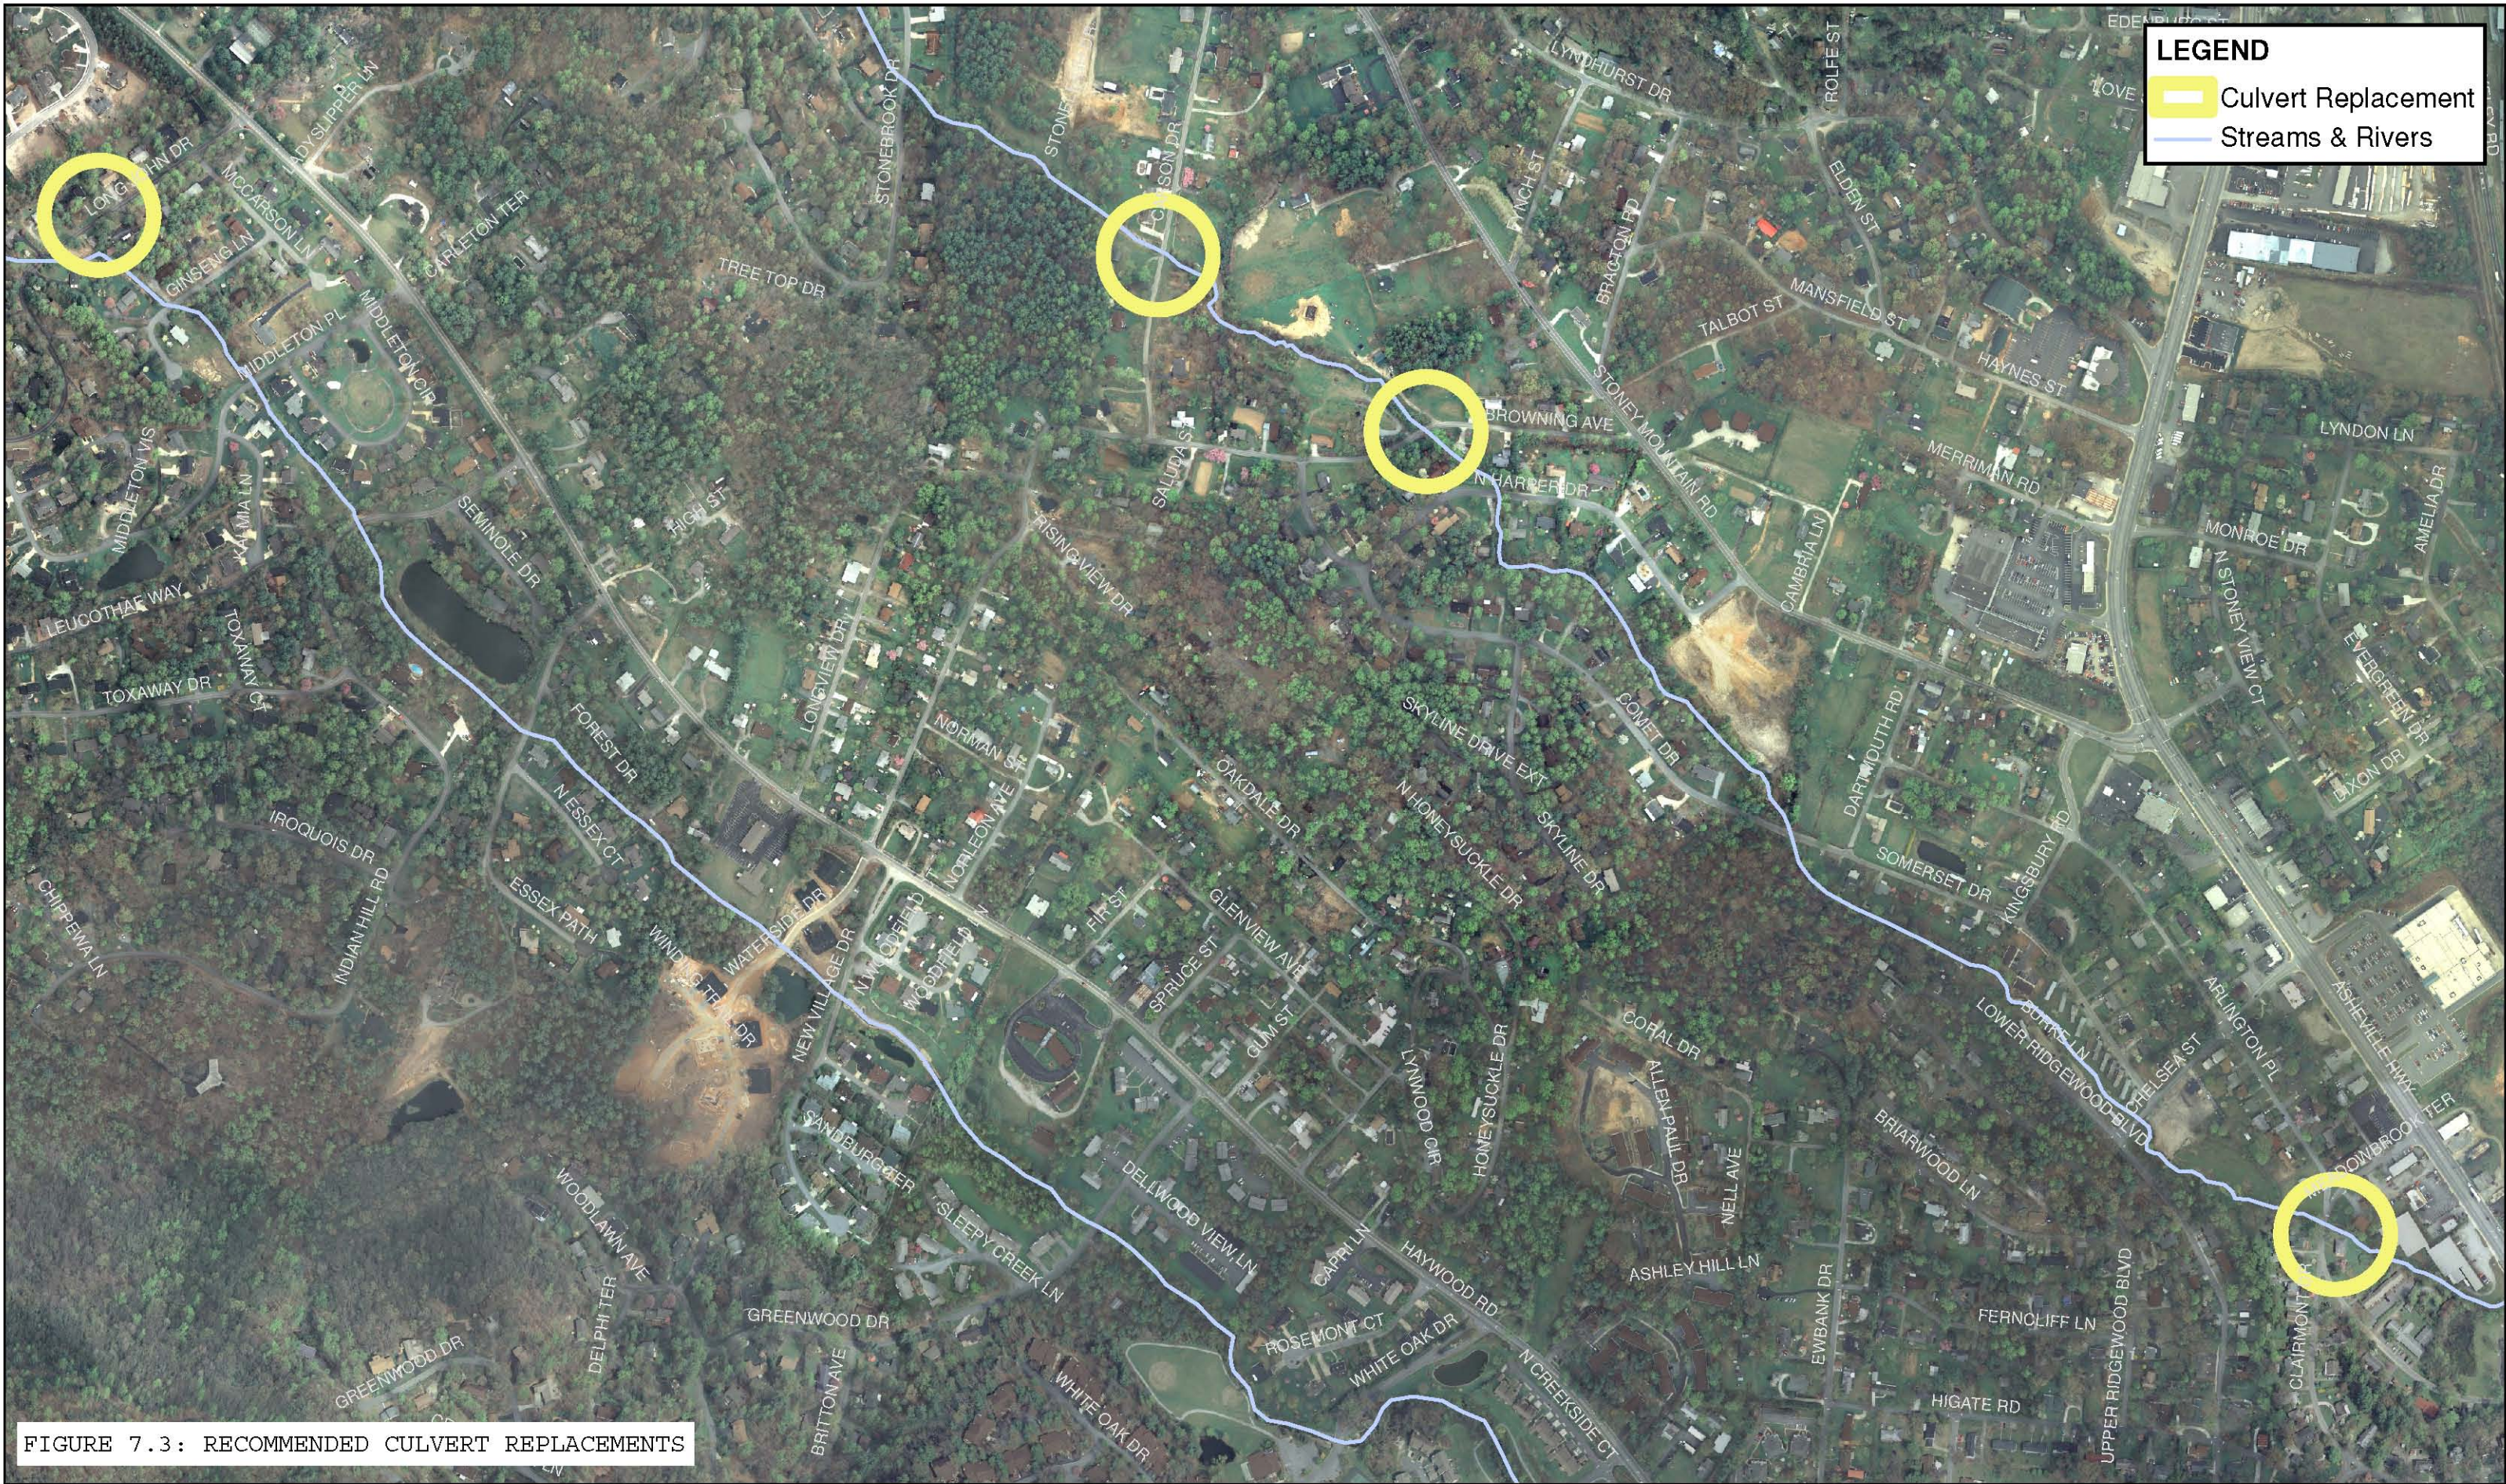
FIGURE 7.3: RECOMMENDED CULVERT REPLACEMENTS

There are four culvert replacements recommended (Figure 7.3). In order of priority they are:

- 1) Long John Drive (2 ft culvert) – Small Tributary to Britton Creek
- 2) Browning Avenue – Britton Creek Tributary 2
- 3) Meadowbrook Terrace – Britton Creek Tributary 2
- 4) Carson Drive – Britton Creek Tributary 2
