**BRITTON CREEK
STORMWATER MASTER PLAN**

**CITY OF HENDERSONVILLE
HENDERSON COUNTY, NORTH CAROLINA**

June, 2011

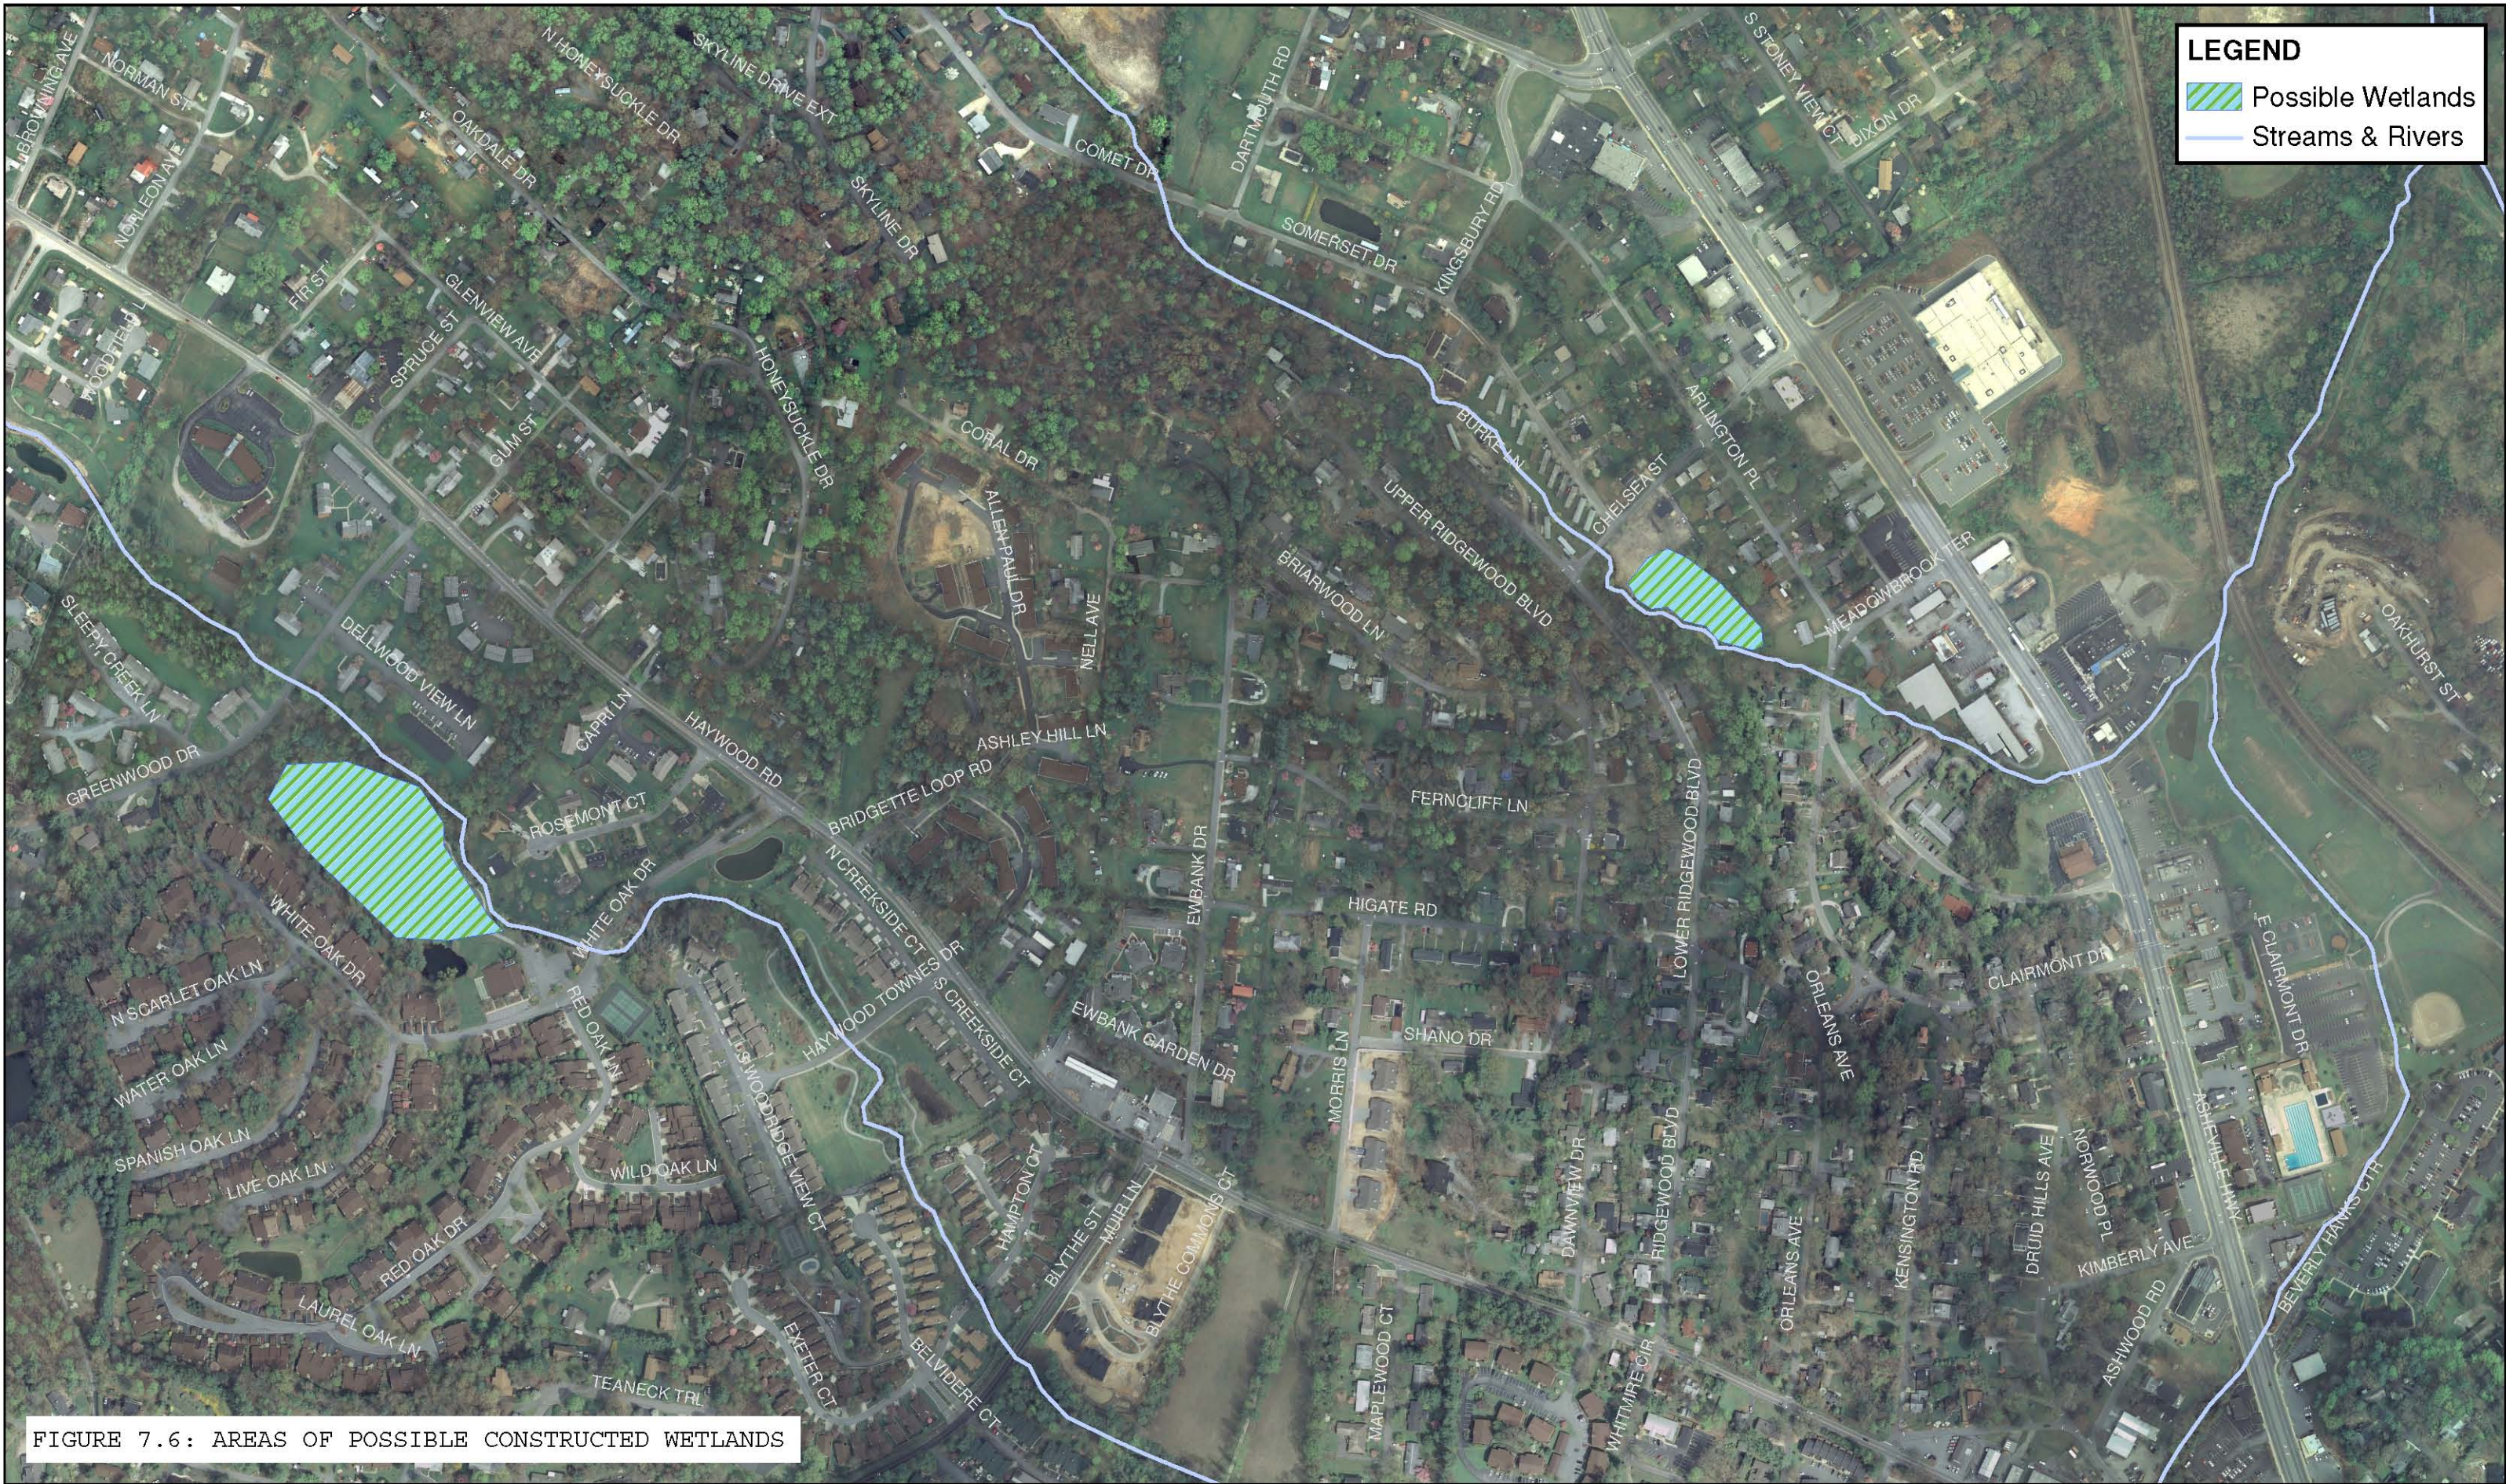
BRITTON CREEK WATERSHED: CITY OF HENDERSONVILLE, NC
 AREAS OF POSSIBLE CONSTRUCTED WETLANDS

There are two locations that should be considered for potential wetland sites. These are shown in Figure 7.6. The locations include the City property that is located just downstream of Chelsea Street along Tributary 2. The other location is along Britton Creek in The Oaks development where the walking trail is located. These projects are described in more detail in Section 7.2.2.

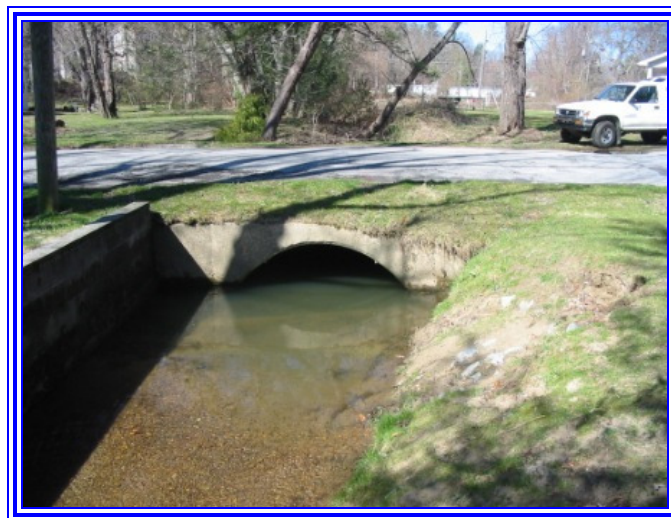
Figure 7.7: Meadowbrook Terrace Culvert.

The Meadowbrook Terrace culvert is considerably obstructed by deposited sediment (Figure 7.7) and its hydraulic capacity is greatly reduced. It cannot function as designed and should be replaced. However, as shown in Section 4, the culvert is overtopped during even the 5 and 10 year storms. Because the road and the immediate area are at elevations below the flood levels, a culvert replacement will not necessarily attenuate flooding.

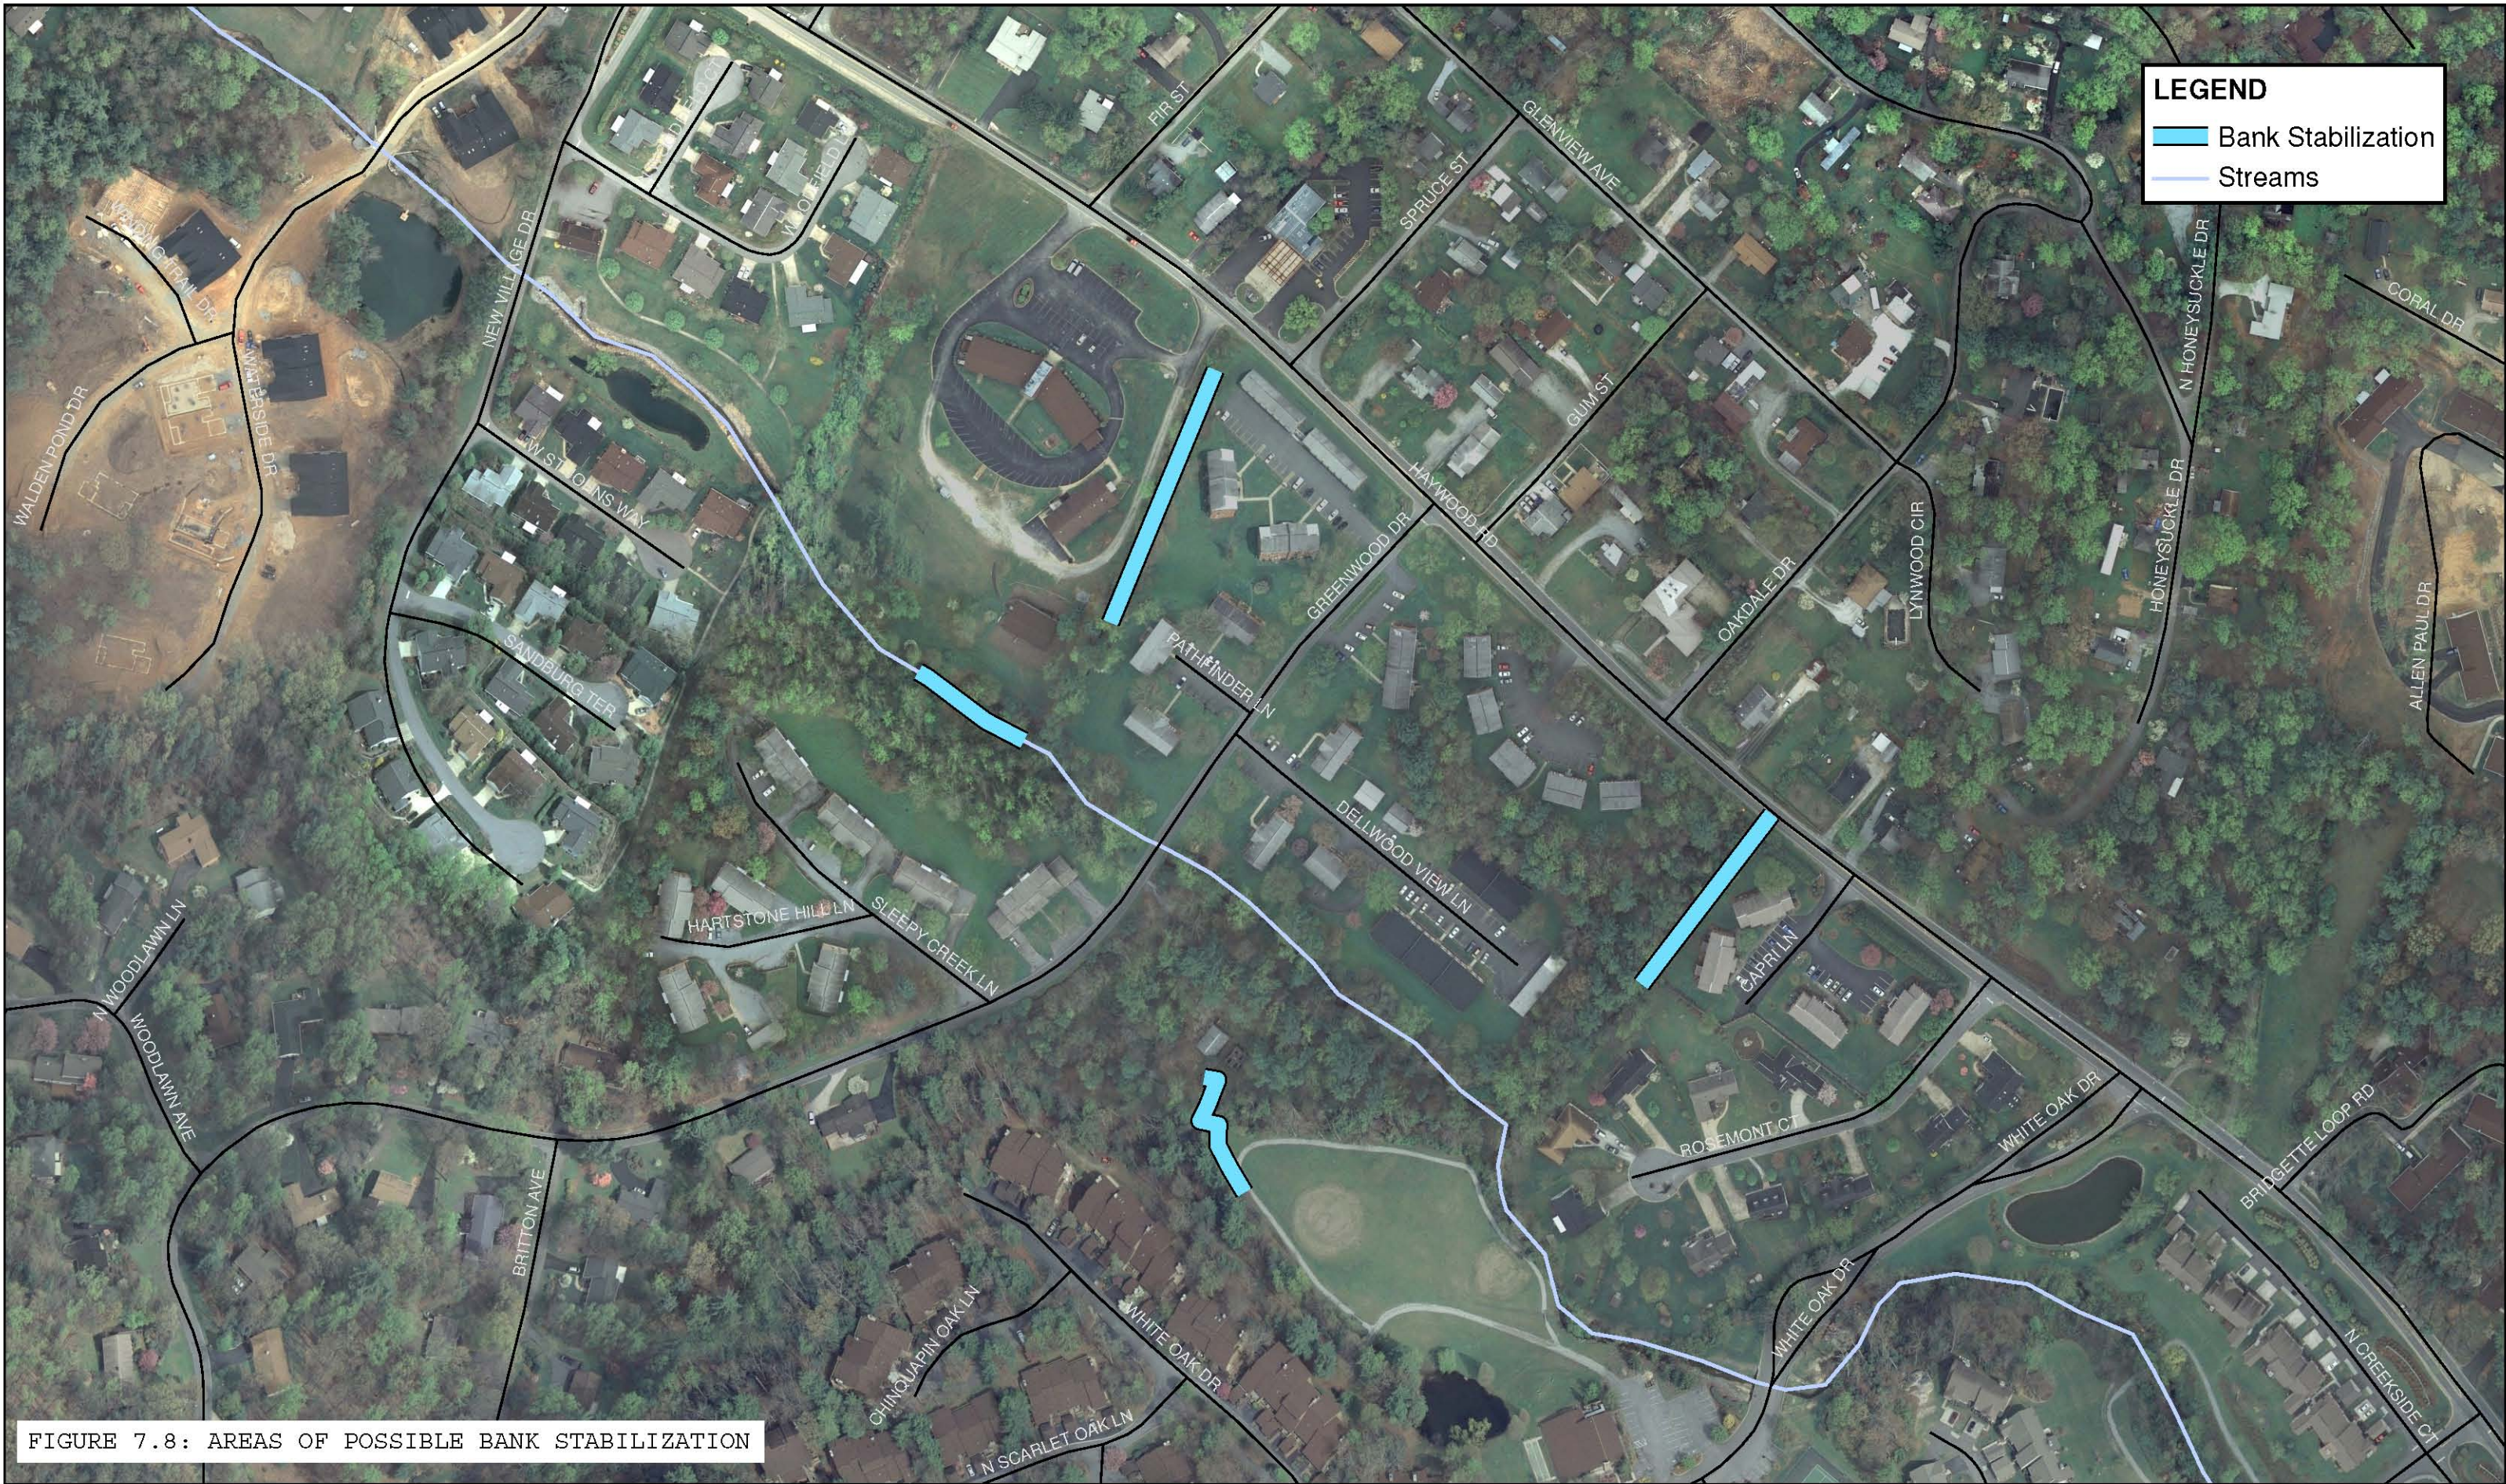
BRITTON CREEK WATERSHED: CITY OF HENDERSONVILLE, NC
 AREAS OF POSSIBLE BANK STABILIZATION

The lower section of Britton Creek Tributary 2 shows evidence of urban impacts. The amount of woody vegetation on its banks is greatly decreased as it approached Chelsea Street. From that area downstream to the Druid Hills Assisted Living center is in poor condition. The retaining wall just downstream of Meadowbrook Terrace is cracking, and erosion is occurring from behind the wall.

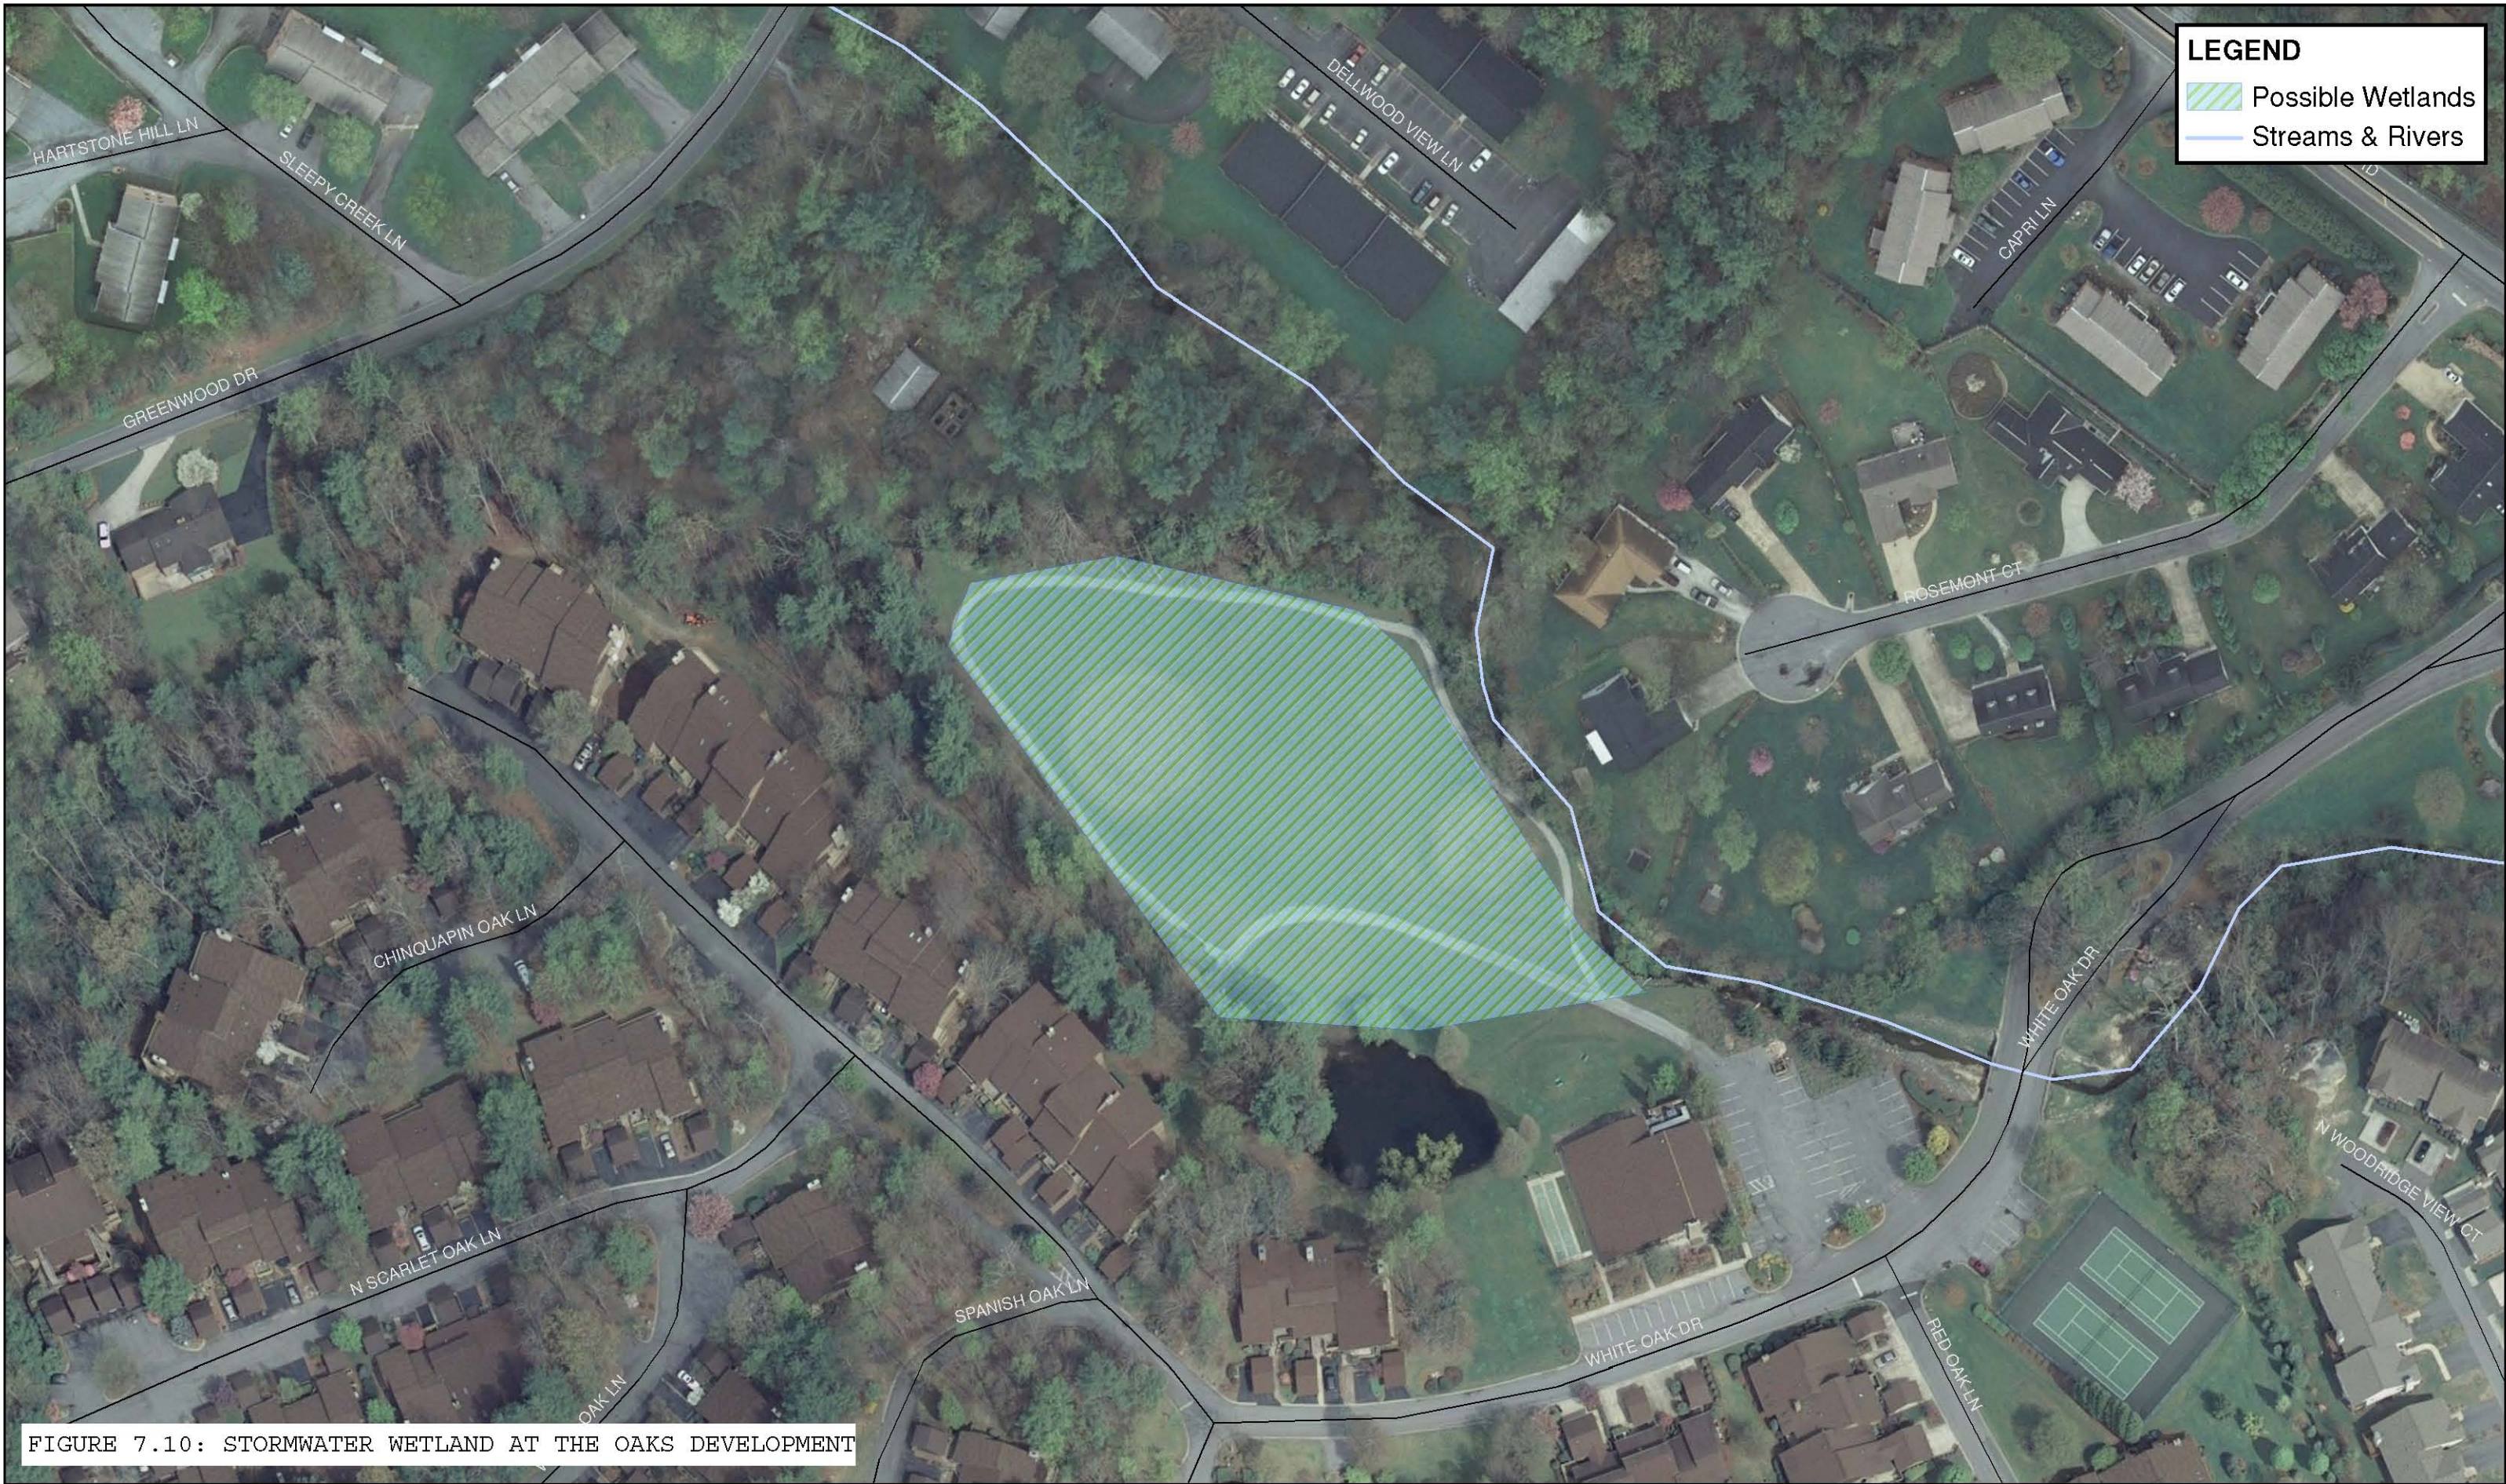
FIGURE 7.10: STORMWATER WETLAND AT THE OAKS DEVELOPMENT

The one-acre stormwater wetland has been designed to provide mountainous bog habitat, with areas of ponded water, higher areas with large trees and in-stream structural habitat ideal for native fish, aquatic insects and amphibians. The project received 401 Certification issued by the NC Division of Water Quality. The system will be maintained by the City under a maintenance plan developed as part of the project design.

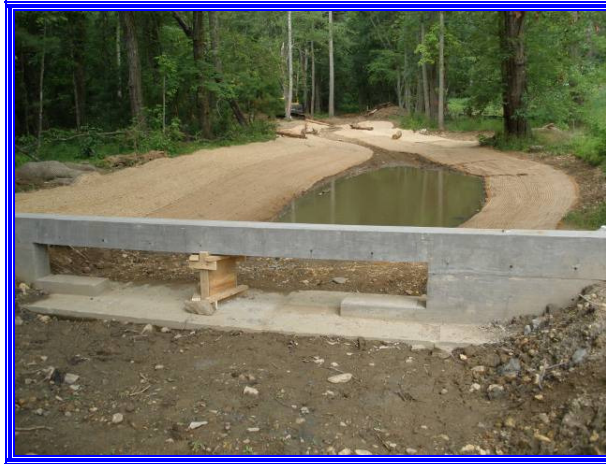
Figure 7.11 Dingle Creek during construction

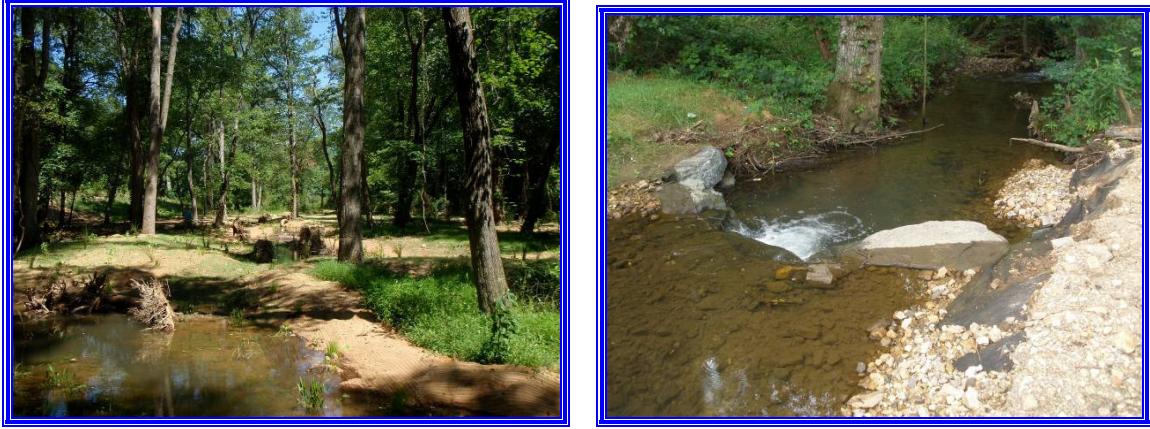
Figure 7.12 Dingle Creek after the enhancement project
